**Reference: Howey Bay Road Bridge and Forestry Road Culvert - OSIM Bridge Inspections 2023  
Summary Letter**

## Howey Bay Road Bridge Inspection

# 2023 OSIM Visual Inspections Howey Bay Bridge 2023-11-22

**Structure Name:** Howey Bay Bridge  
**Structure Type:** Steel Girder  
**Year Built:** Unknown  
**Yr. of Last Rehab:** 2021

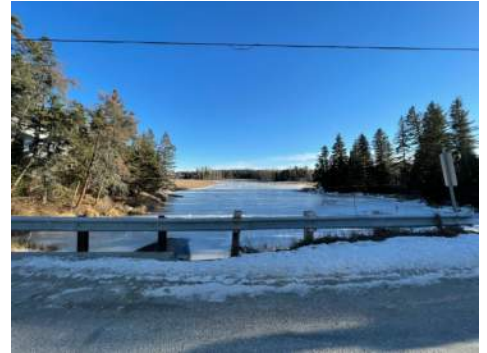
Upstream looking South

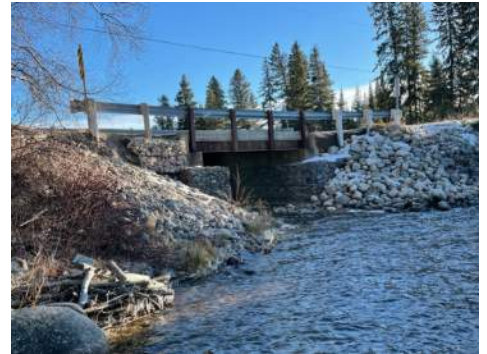
North elevation

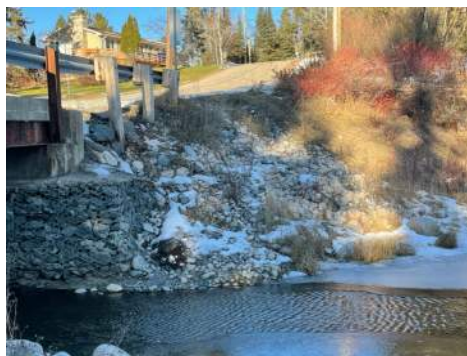
SE embankment

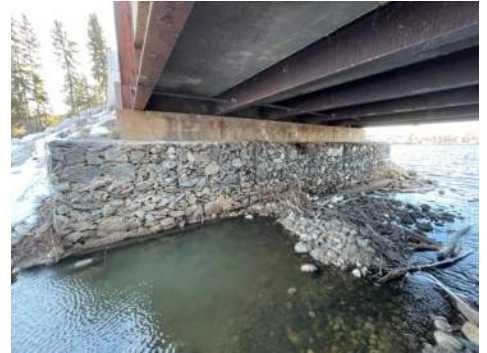
SU2 West abutment

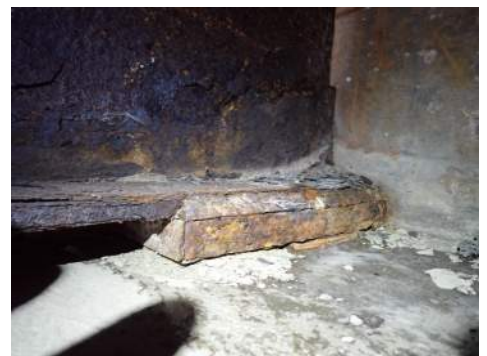
Typical interior bearing - SU2.

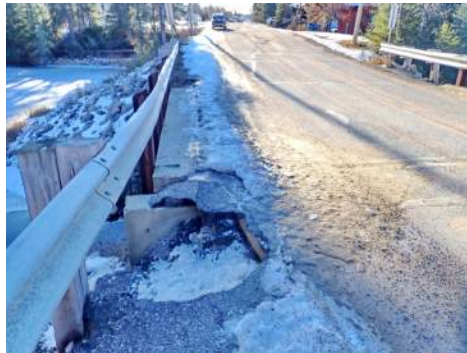
Approach - Wearing surface - SE.  
Note: Erosion trough encroaching roadway

**Recommended Work:**                      None ☐      6-10 Years ☐      1-5 Years ☐      <1 Year ☐      Urgent ☒  
 Repair asphalt on NE, SE, and SW corners in conjunction with embankment repairs.

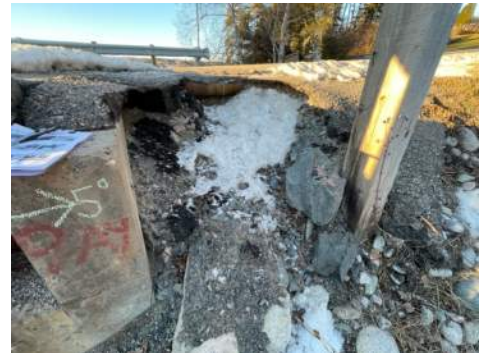
Approach - Wearing surface - SE.  
Note: Erosion trough encroaching roadway

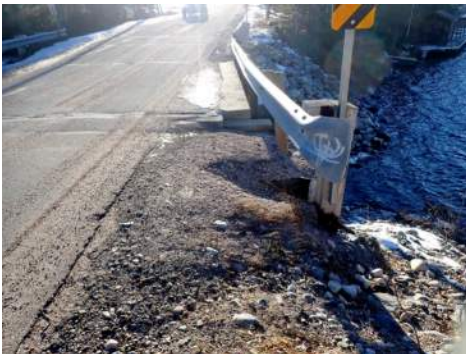
Approach - Wearing surface - NE.  
Note: Erosion starting to encroach roadway

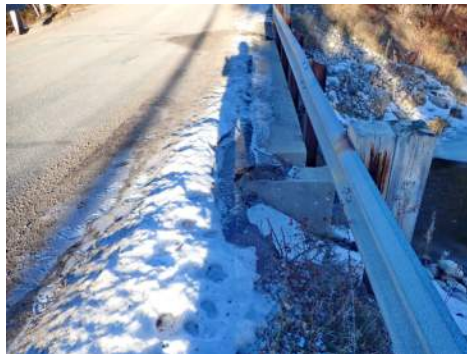
Approach - Wearing surface - SW.  
Note: Erosion trough encroaching roadway

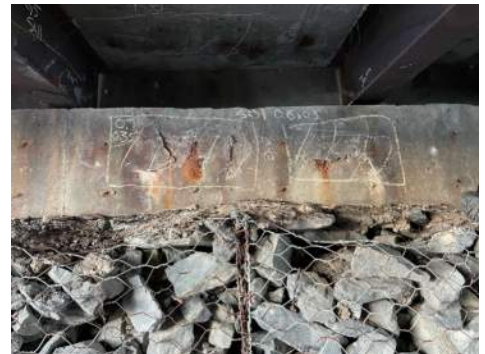
SU1 Abutment Wall. Note: Typical delamination, efflorescence and rust staining.

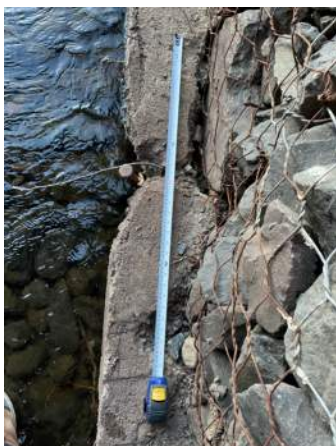
SU1 Abutment Wall - Footing. Note: Typical crack and spalls.

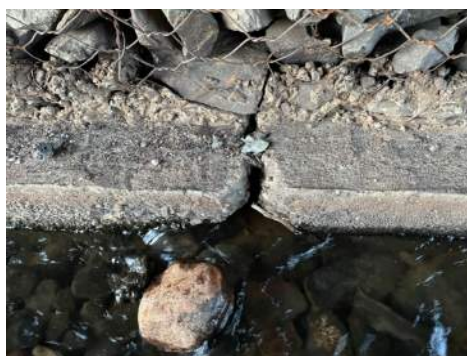
SU1 Abutment Wall - Footing. Note: Wide crack.

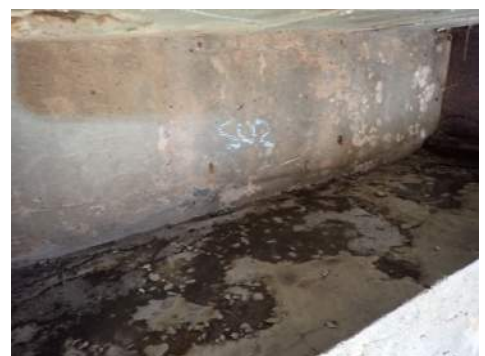
SU2 Abutment wall - between G1/G2.  
Note: Disintegration of bearing seat.

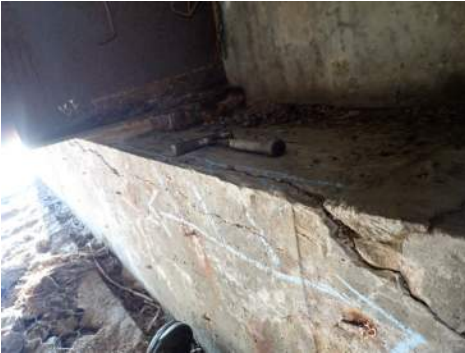
SU2 Abutment wall - between G3/G4.  
Note typical delamination, efflorescence and rust staining.

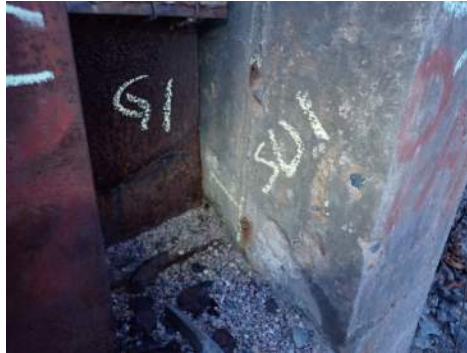
**Comments:**  
 Light scaling typical. Isolated hairline cracks and light pop-outs.  
 SU1: Mechanical spall behind both G1 and G6 bottom flange.

SU1 Ballast wall - at G1. Note:  
Mechanical spall behind bottom flange.

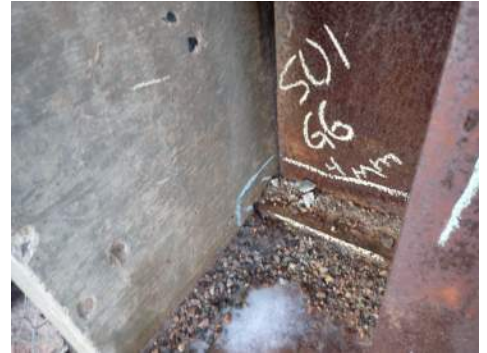
SU1 Ballast wall - at G6. Note:  
Mechanical spall behind bottom flange.

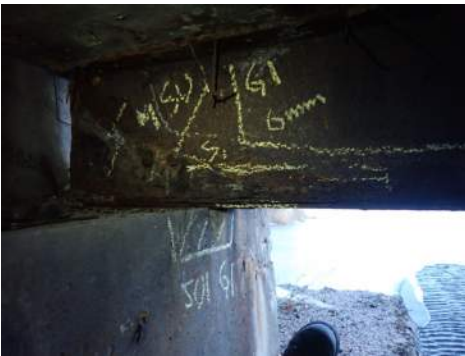
Light corrosion typical. Medium corrosion at the ends throughout. SU1: Isolated area of severe corrosion on the web. Typical severe corrosion and section loss on bottom flanges up to 8mm at SU1 and 3mm at SU2. (Flange thickness should be ~14mm)

G1 at SU1. Note: Typical corrosion and  
spall below girder.

Recommend replacing bridge.

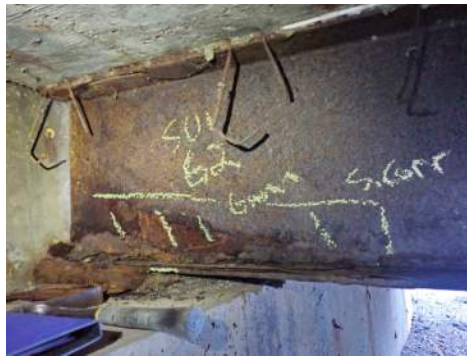
G2 at SU1. Note: Typical corrosion.

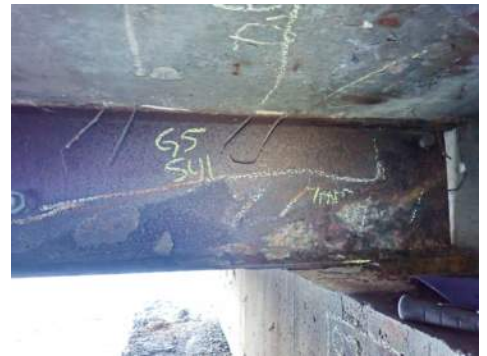
G5 at SU1. Note: Typical corrosion.

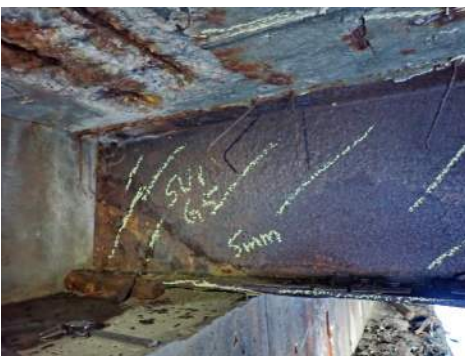
G5 at SU1. Note: Typical corrosion.

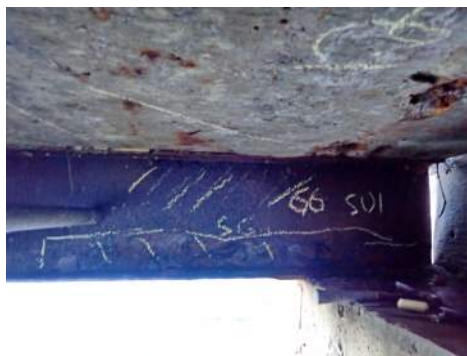
G6 at SU1. Note: Typical corrosion.

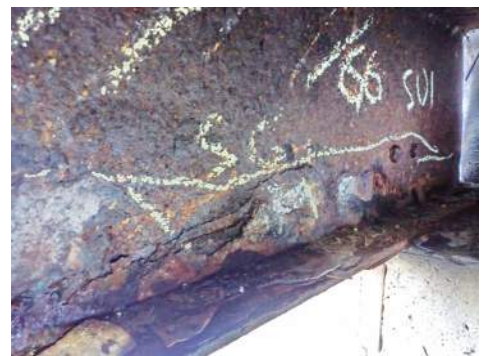
G6 at SU1. Note: Typical corrosion.

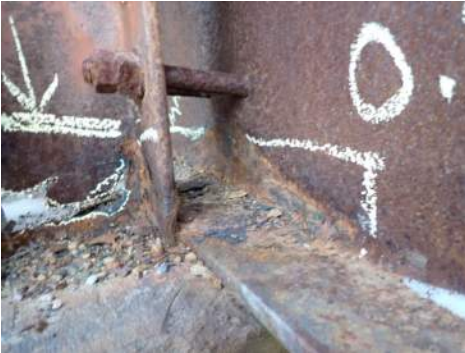
G6 at SU1. Note: Corrosion on web.

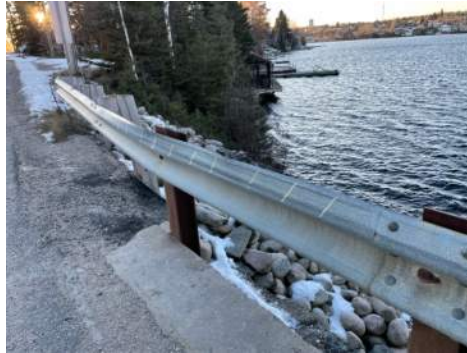
Isolated light corrosion. Isolated permanent deformations. No other observed defects.

Railing Systems - NW. Note: Permanent deformation.

Replace section of north railing from deck Post 3 to west approach Post 1.

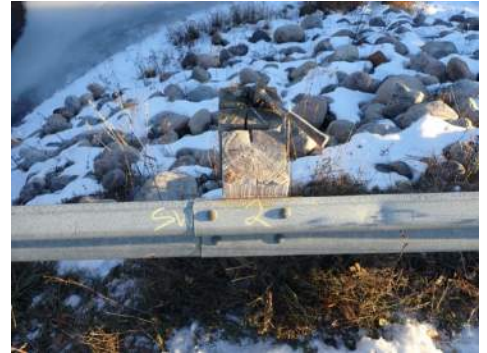
Posts - SW Approach - PT2. Note: Rot on top face.

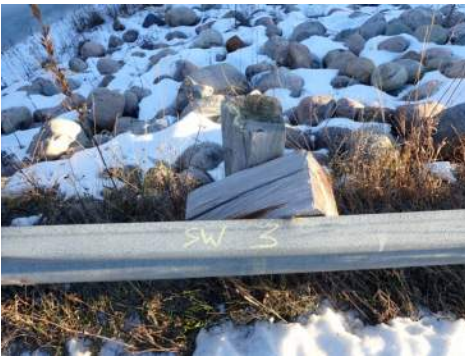
Posts - SW Approach - PT3. Note: Rotated blocking and section loss on post.

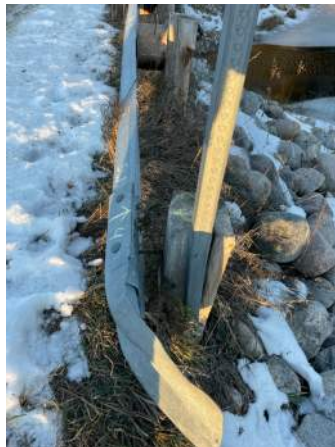
Posts - SW Approach - PT4. Note: Missing timber blocking.

Replace SW Post 4 blocking.

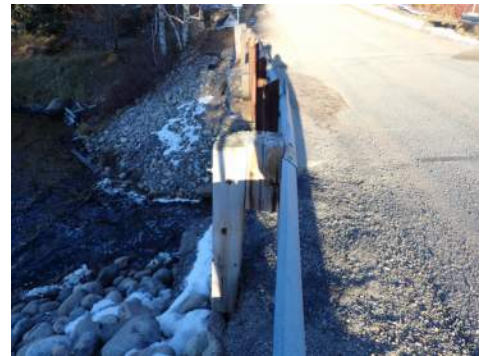
Posts - NW Approach - PT1. Note: Typical bottom of post is moving out due to loss of embankment material.

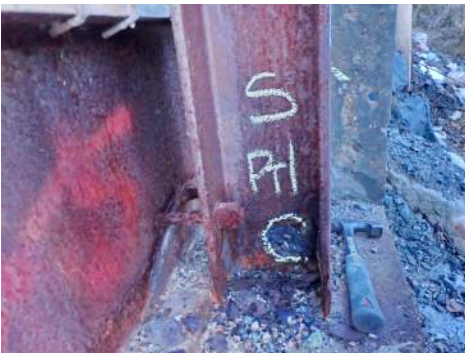
Light corrosion typical. Medium corrosion on Post 4 on North and South side. Severe corrosion with hole through web on bottom of Post 1 on North and South side.

Posts - South PT1. Note: Corrosion hole through bottom of web.

Replace Post 1 and 4 on North and South sides.

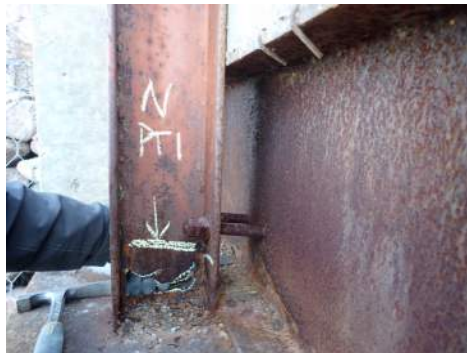
Posts - North PT1. Note: Corrosion hole through bottom of web.

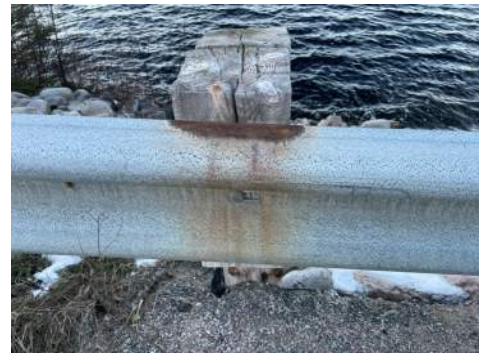
**Comments:**  
Isolated category 2 rusting. No other observed defects.

Coatings - Railing. Note: Typical rusting.

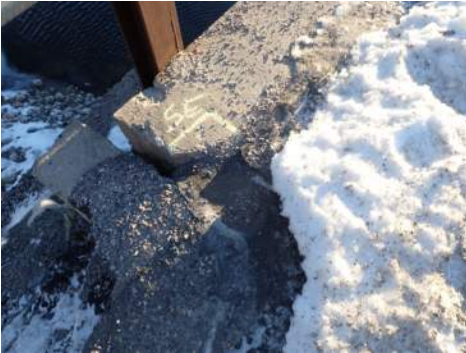
**Comments:**  
Exposed deck top has light scaling typical. Spall with exposed reinforcement at SE corner repaired with asphalt.

Deck top - SE. Note: Spall repaired with asphalt.

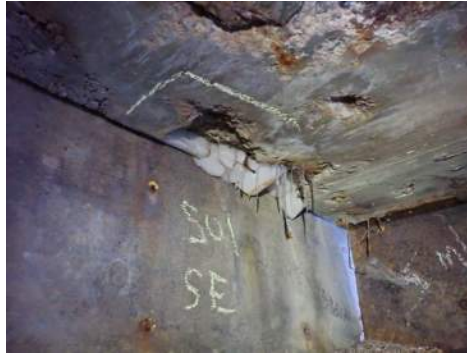
Light scaling typical. Light to severe honeycombing. Rust staining at the abutments. Typical severe delaminations and spalls with exposed corroded reinforcement at the abutments. Full depth section loss at SU1 between G1/G2 (~0.6 m x 0.2 m) temporarily repaired with foam to support wearing surface.

Deck Soffit - Interior - SU1 between G1/G2. Note: Spall and temporary repair.

Repair spall at SU1 between G1/G2 with structural concrete.

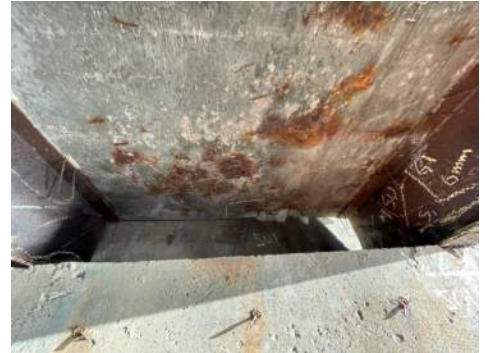
Deck Soffit - Interior - SU1 between G1/G2. Note: Spall with temporary repair, and delamination.

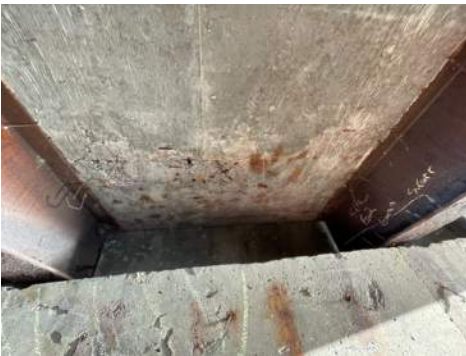
Deck Soffit - Interior - SU1 between G2/G3. Note: Typical honeycombing, delamination and rust staining.

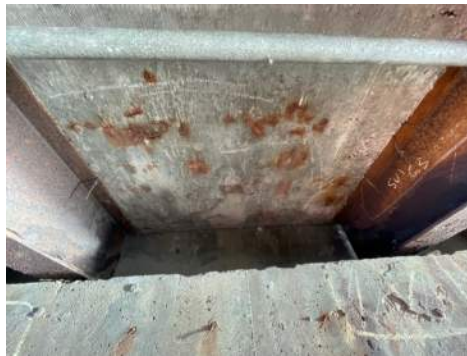
Deck Soffit - Interior - SU1 between G3/G4. Note: Typical delamination and rust staining.

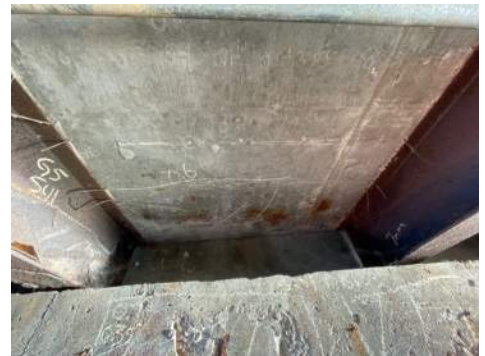
Deck Soffit - Interior - SU1 between G4/G5. Note: Typical delamination and rust staining.

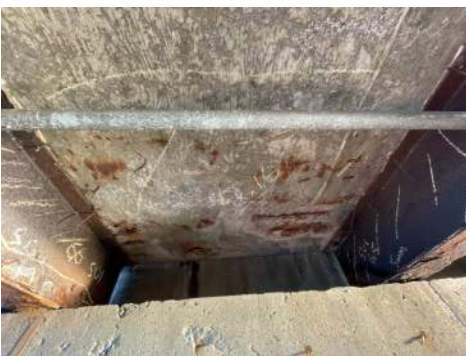
Deck Soffit - Interior - SU1 between G5/G6. Note: Typical spalls with exposed rebar, delamination and rust

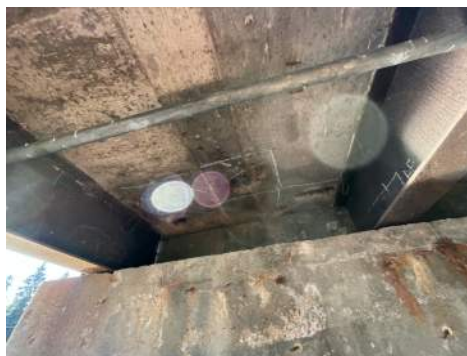
Deck Soffit - Interior - SU2 between G1/G2. Note: Typical spalls with exposed rebar, delamination and rust

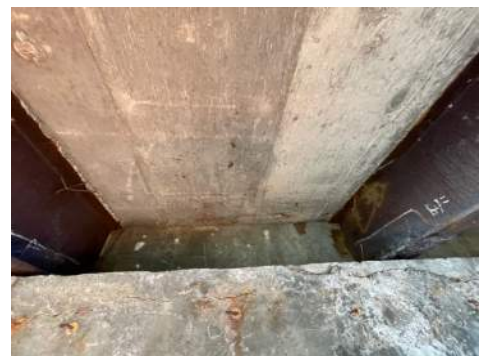
Deck Soffit - Interior - SU2 between G2/G3. Note: Typical spalls, delamination and rust staining.

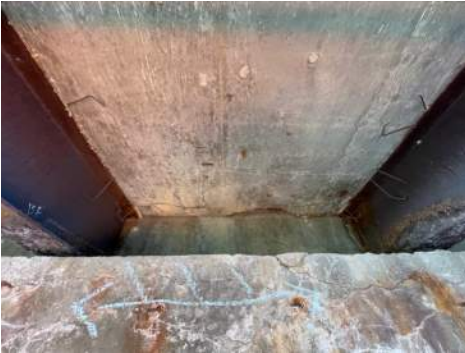
Deck Soffit - Interior - SU2 between G3/G4. Note: Typical spalls with exposed rebar, delamination and rust

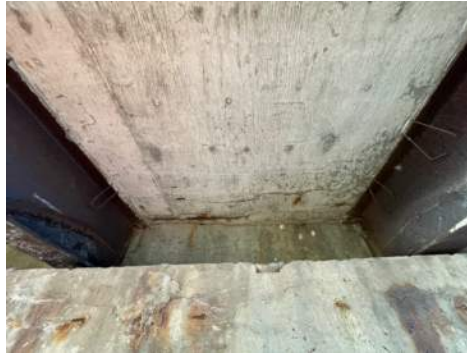
Deck Soffit - Interior - SU2 between G4/G5. Note: Typical spalls with exposed rebar, delamination and rust

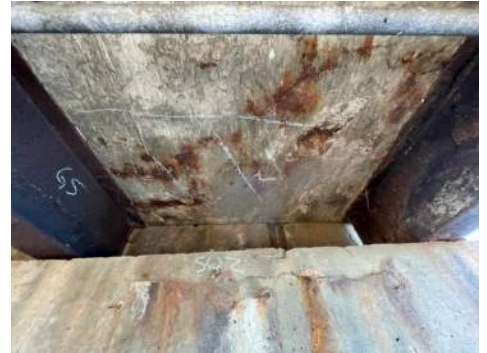
Deck Soffit - Interior - SU2 between G5/G6. Note: Typical spalls with exposed rebar, delamination and rust

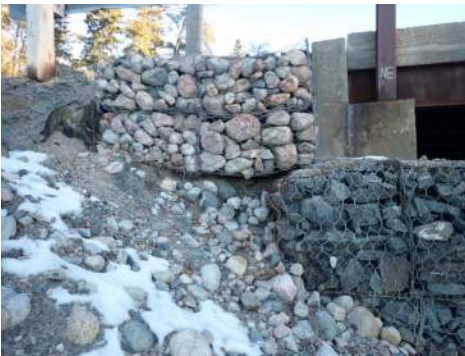
Embankments - NE. Note: Erosion under gabions.

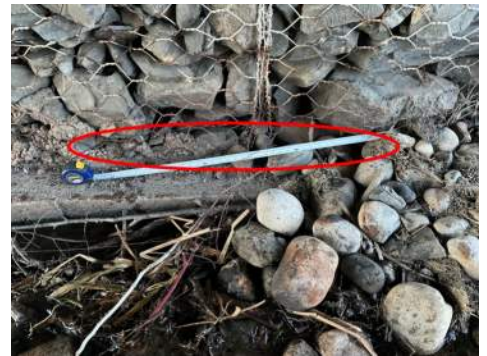
Slope Protection - SU1. Note: Typical holes in gabion wires.

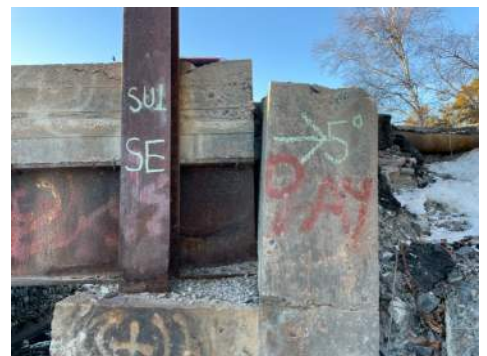
- Rotation of the abutments is causing gaps at the missing deck joint locations and causing spalls in the ballast walls from the girder bottom flanges. Comparing deck measurements, the substructure has not exhibited movement since the previous inspection in 2021 however, Stantec recommends this monitoring continue during future inspections.

Foundation - SE. Note: Gap between decktop and ballast wall at SU1

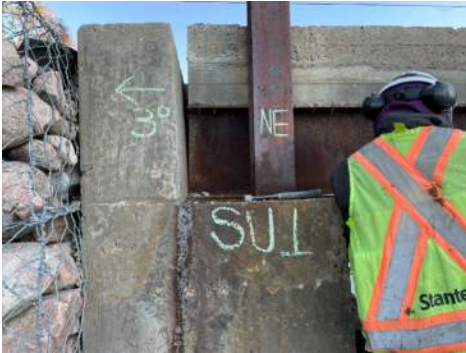
Foundation - NE. Note: Gap between deck top and ballast wall at SU1

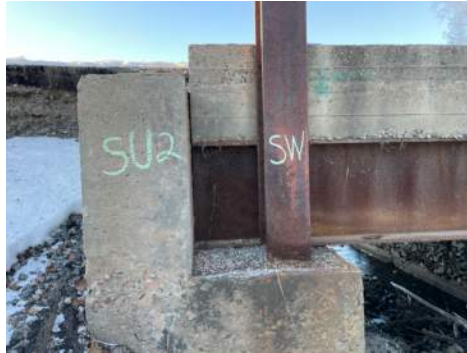
Foundation - SW. Note: Gap between deck top and ballast wall at SU2

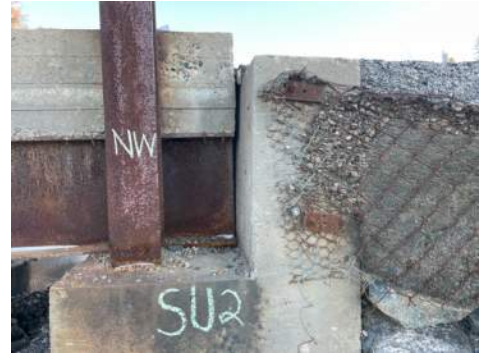
Foundation - NW. Note: Gap between deck top ballast wall at SU2

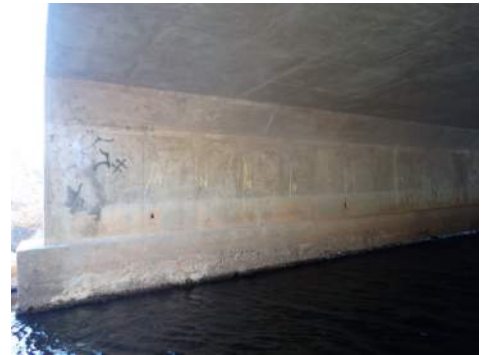
Culvert - South wall. Note: Typical HL-N cracks.

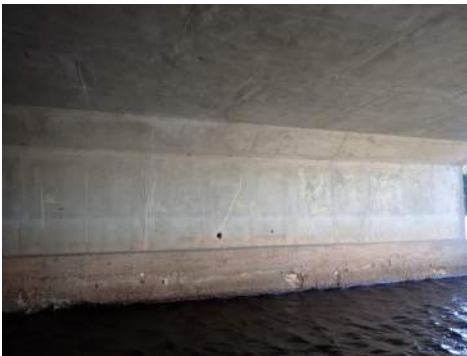
Culvert - South wall. Note: HL-M vertical cracks near Inlet.

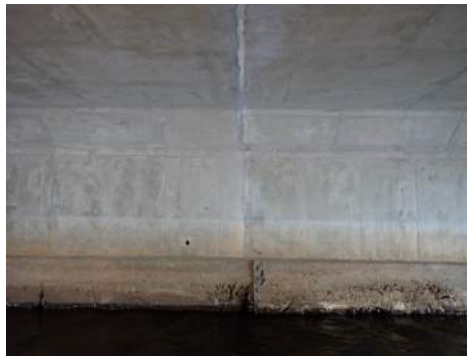
Culvert - North wall - mid-span. Note: Hairline to medium crack

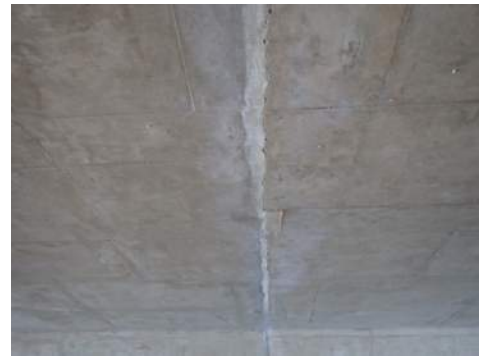
Culvert soffit - mid-span. Note: Hairline to medium crack

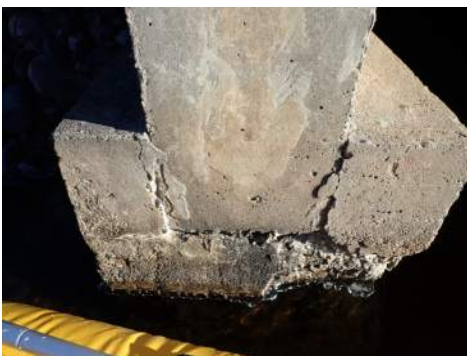
Inlet - NW corner. Note: Disintegration of footing

1. Rehabilitate the concrete footing that currently has extensive and progressing erosion along with exposed corroded rebar under the waterline (<1 year)
2. Add slope protection to the northwest embankment toe (<1 year)

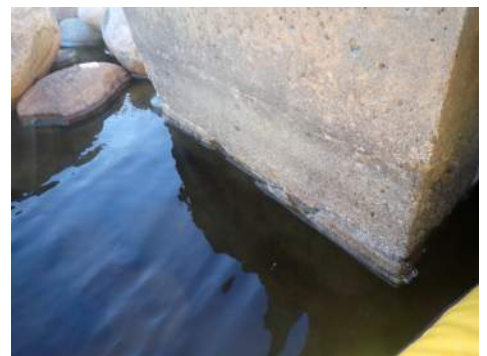
Outlet - SE corner. Note: Disintegration of concrete footing below waterline.

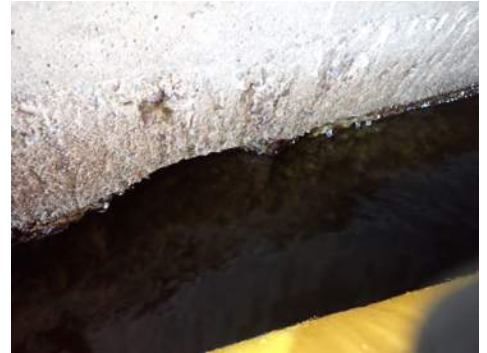
Footing - South wall. Note: Typical disintegration with exposed rebar.

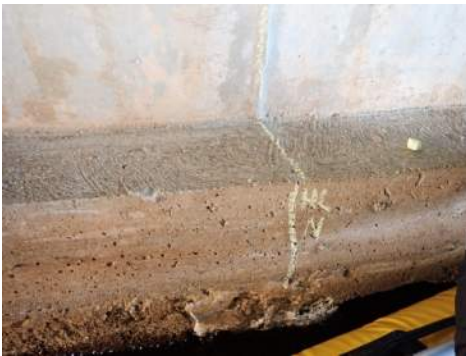
Footing - South wall. Note: Hairline to narrow crack extending from culvert into footing.

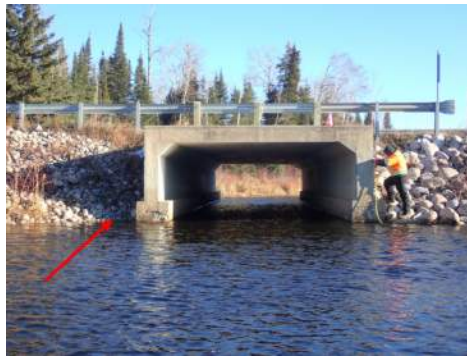
Embankments - West elevation. Note: Slight scour of NW embankment toe.

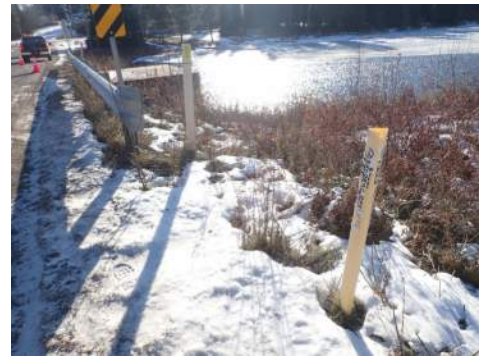
NW Embankment. Note: Utility markers.
