**Building Condition Assessment
(BCA)**

BCA Report for Cochenour Arena

10 William St.

Report Date
July 14, 2022

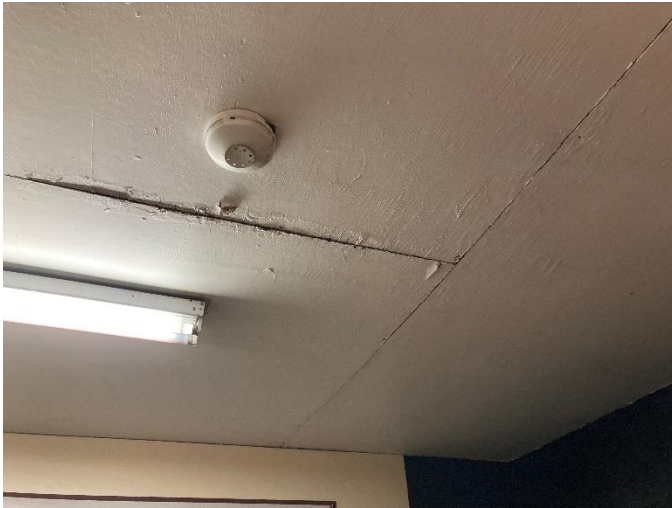
Figure 5 – Damaged ceiling equipment storage room within rink

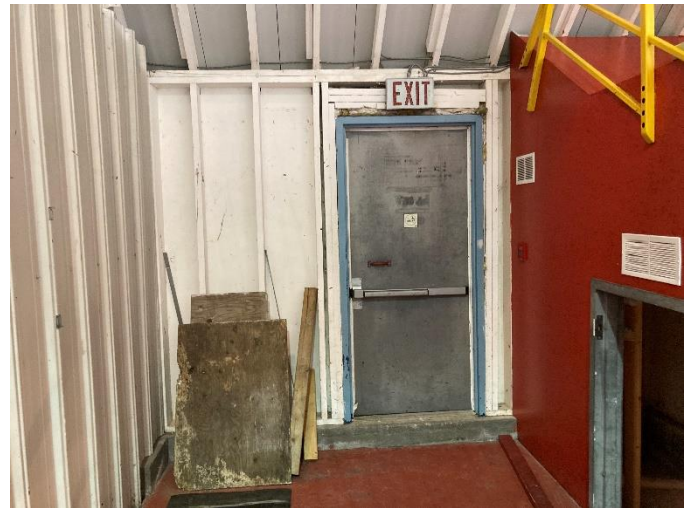
- a. The rink exit doors do not have exterior landing or clear access to safely exit the building. The rink doors also have a concrete curb that limit their use by those with accessibility limitations. The north side was currently blocked by snow and the exit signage covered. The client has reviewed this condition with the local fire chief. The south side exit doors do not have a clear path to the street to safely exit the building.

Figure 6 – Exit door with concrete curb from rink not meeting accessibility requirements

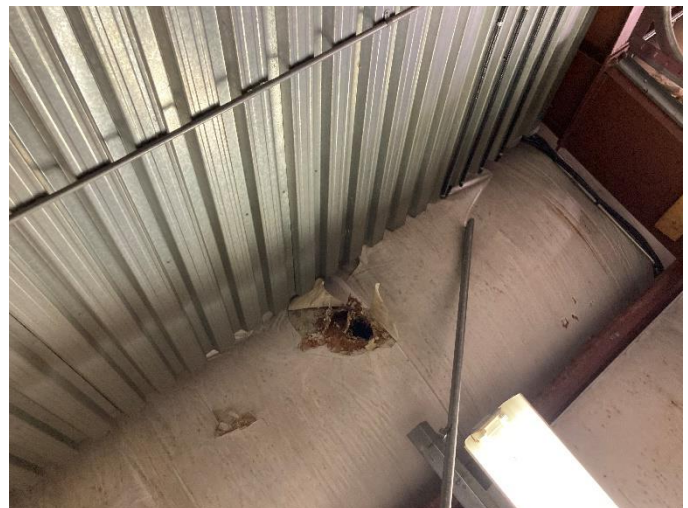
- a. The roof at the west side is pre-finished metal cladding with blanket insulation over pre-engineered purlins. The roof at the west side has active leaks at the roof low point with damaged roof and wall insulation.
- b. The roof on the east side is a similar construction. A leak was identified between the arena and east addition in a storage room
- c. Roof gutters and rainwater leaders are not a part of the building.

Figure 8 – leaks and damage to roof in ice resurfacer room

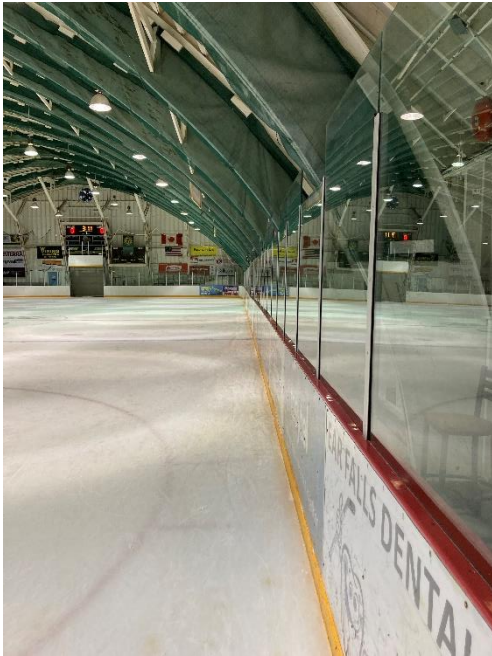
Figure 9 – glulam structure interfering with dasher board glass

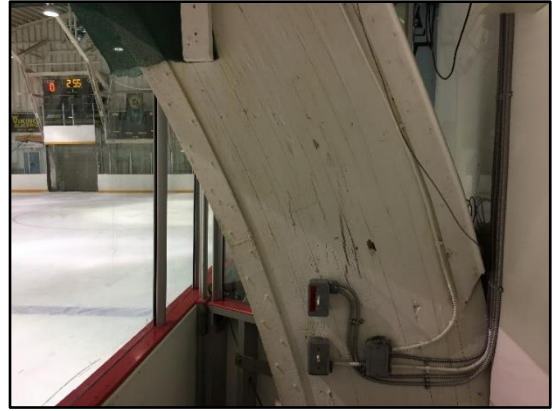
Figure 2 – Cracks in the glulam arched beams indicating delamination.

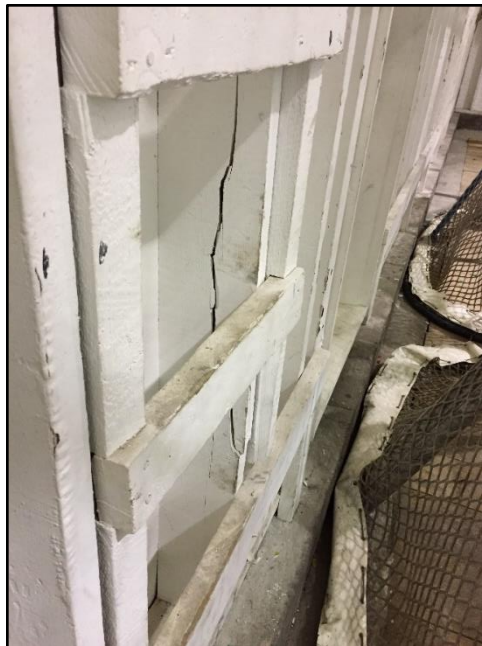
Figure 3 – Cracked stud at west wall of the arena.

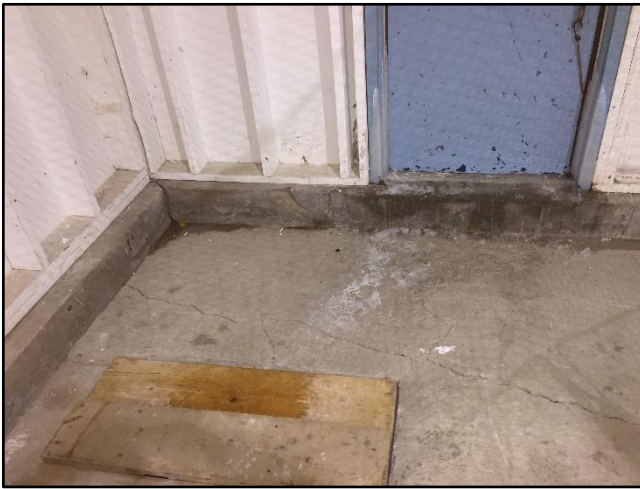
Figure 6 – Cracks in grade beams and concrete

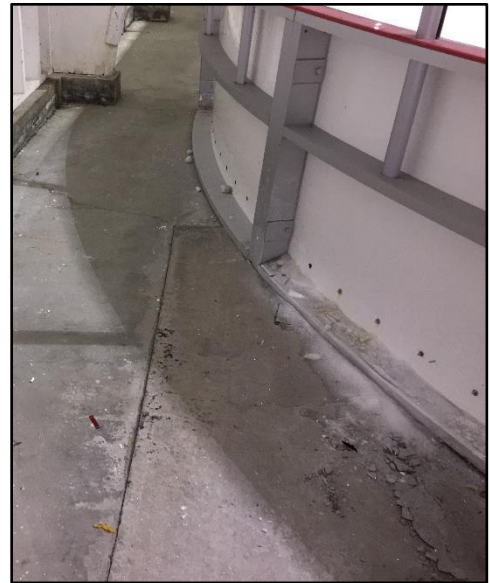
Figure 7 – Concrete floor cracks under ice board to the north-west corner of ice rink

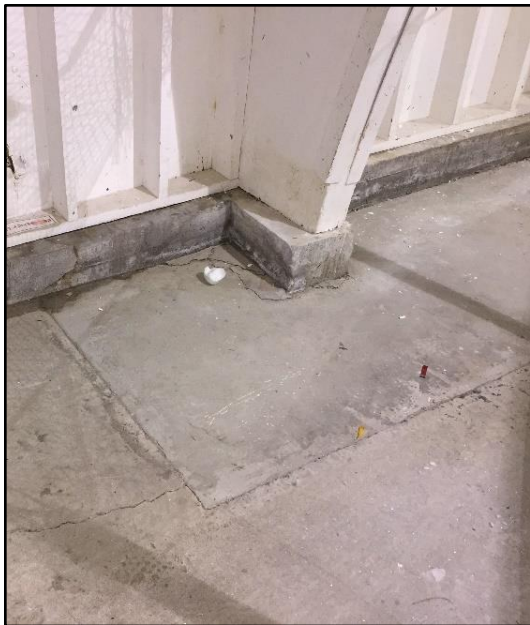
Figure 8 – Cracks in concrete slab near pilaster

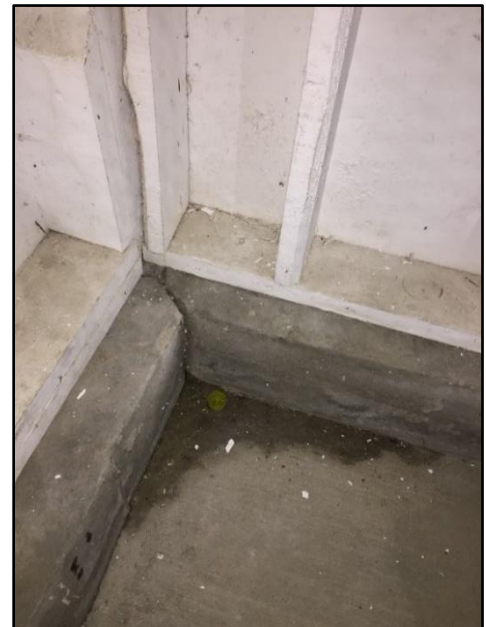
Figure 9 – Crack in grade beam at the north-west corner of the arena

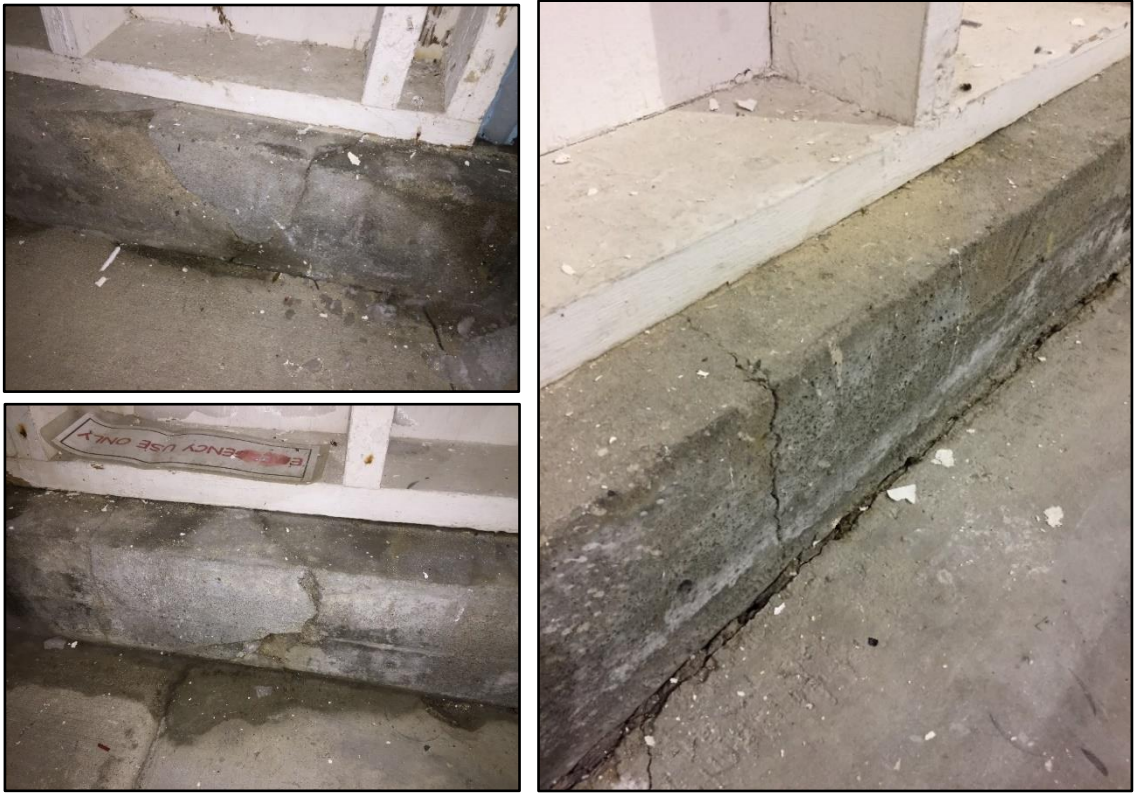
Figure 10 – Crack in grade beam at the north-west corner of the arena

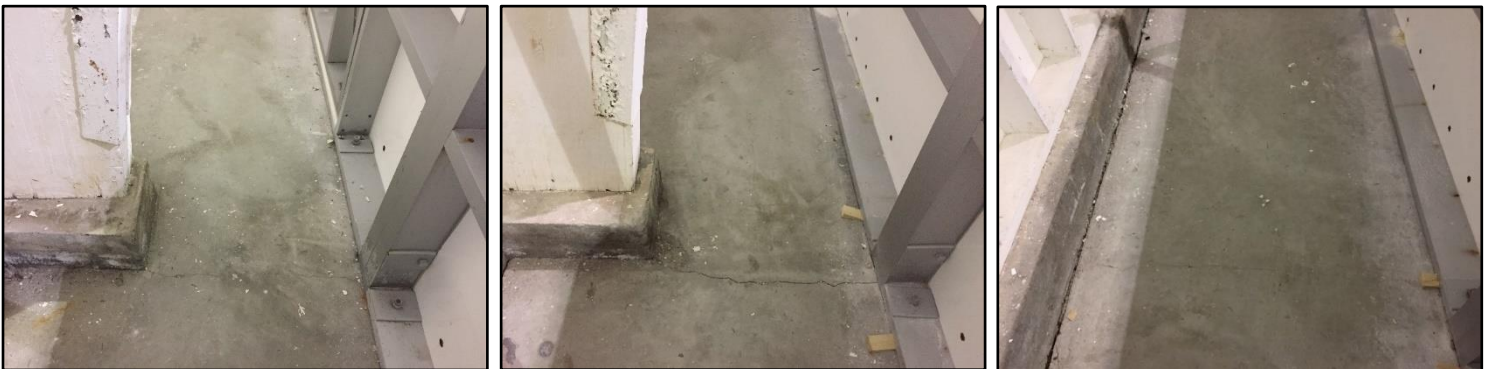
Figure 11 – Slab-on-grade shrinkage cracking

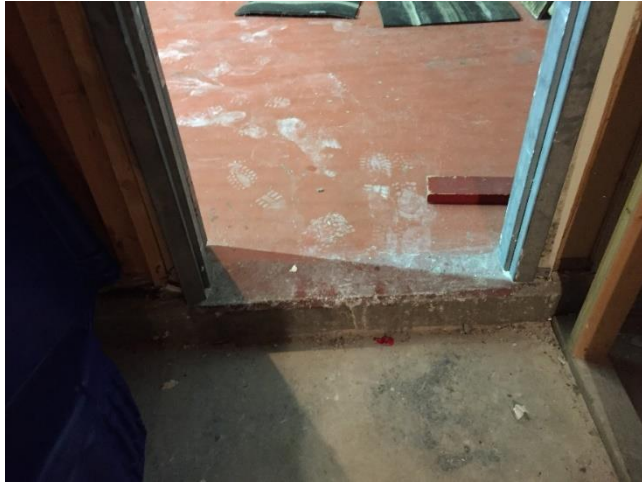
Figure 12 – Difference in concrete slab elevation

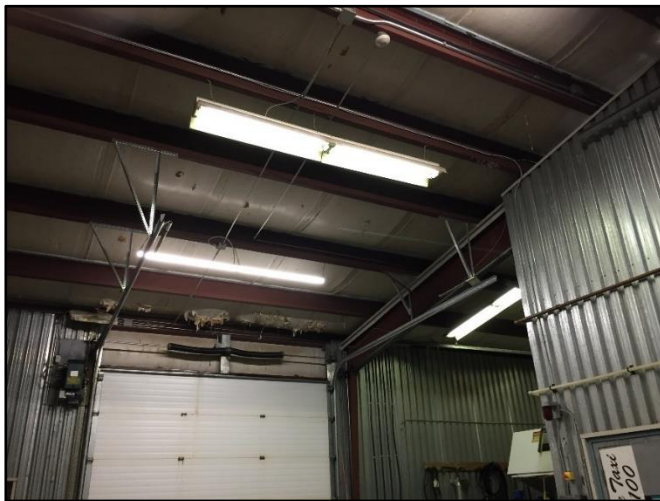
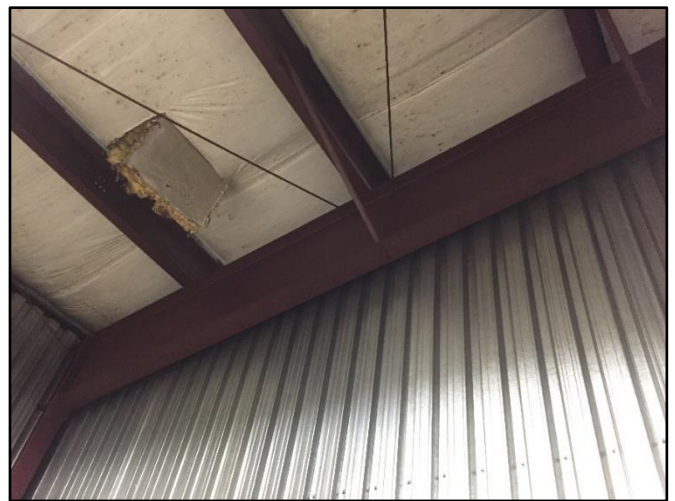
Figure 14 – Damage in Ice Resurfacer room roofing
membrane

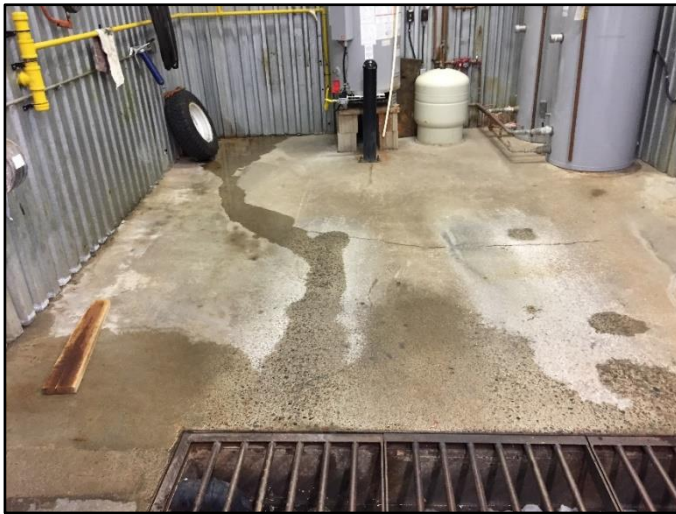
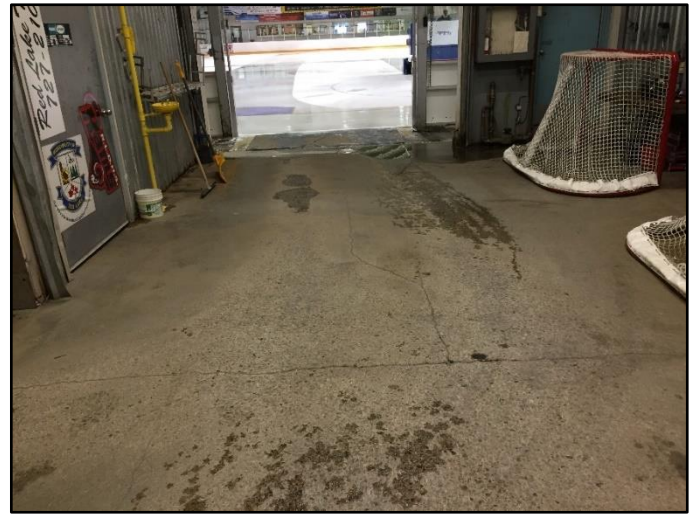
Figure 15 – Cracking and spalling of concrete slab in Ice Resurfacer Room

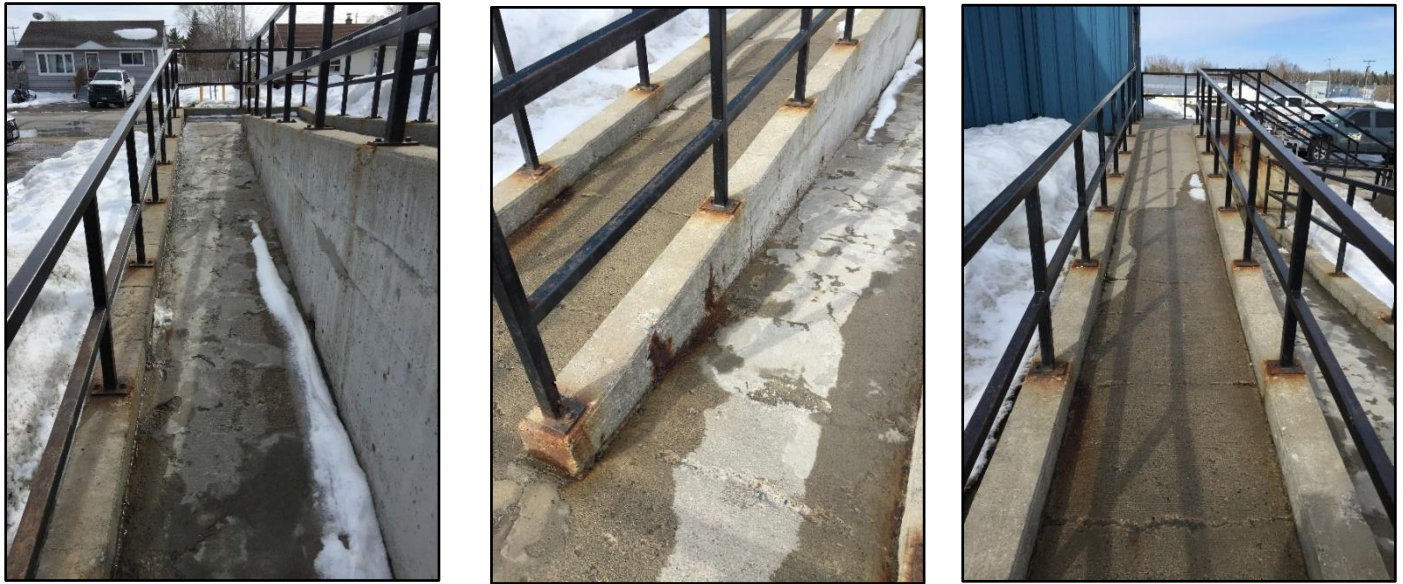
Figure 19 – Concrete ramp deterioration in front of the reception area

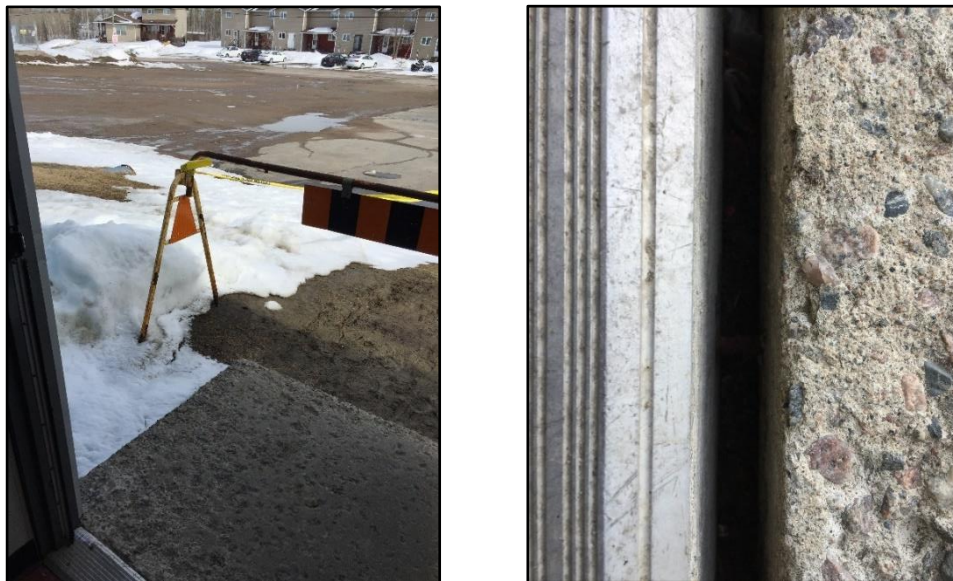
Figure 20 – Exterior concrete pad deteriorations near dressing rooms area

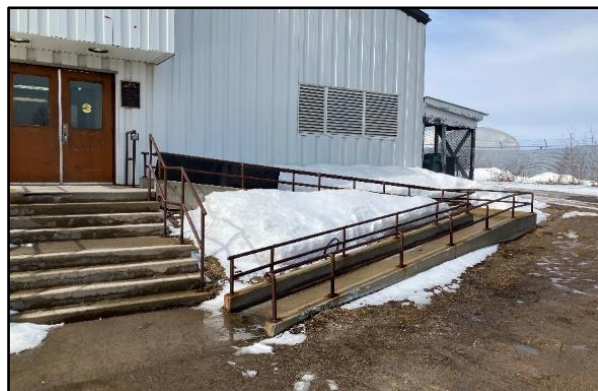
Figure 25 – Deteriorations in Entry stairs and ramp to the community hall

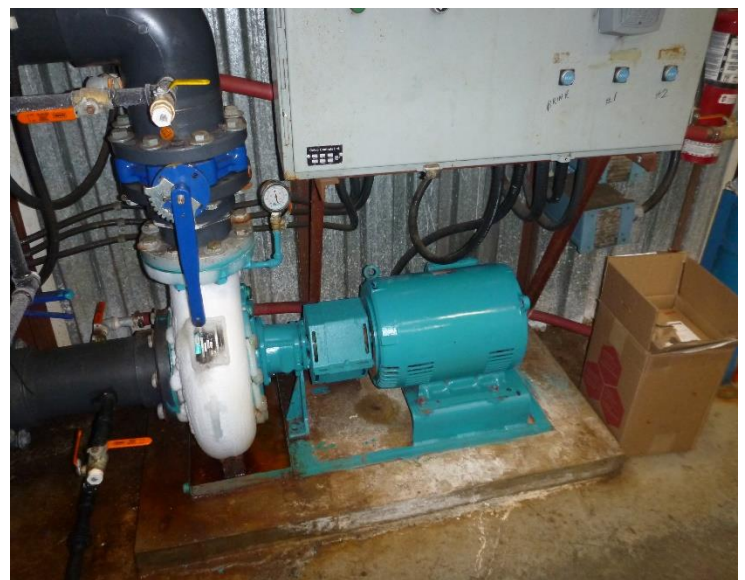
Figure 24– Frosted brine pump impeller casing
