Balmertown Fire Station

Energy Efficiency Evaluation, 10044

FINAL REPORT - JULY 2012

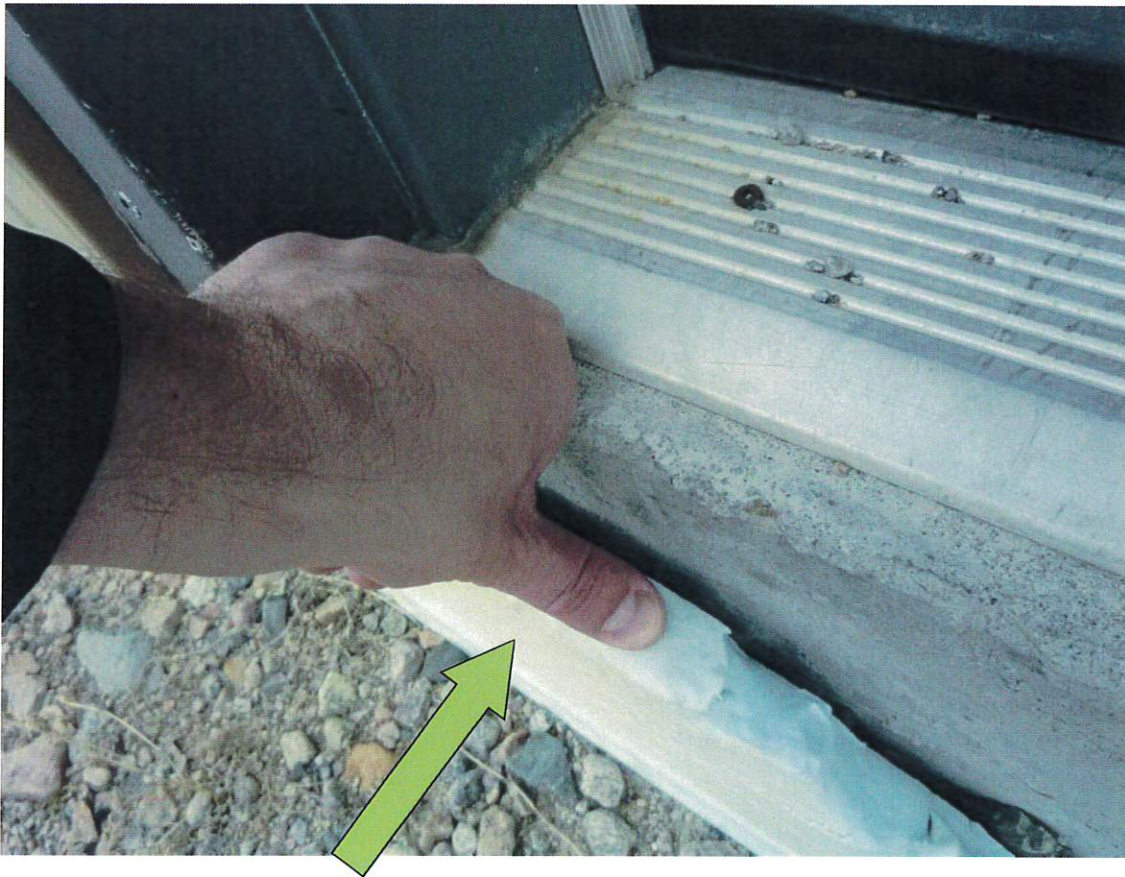
Rigid insulation is present, however, exposed and unprotected at the slab perimeter (photo below). Fitment of insulation is also poor. Nominal insulation value for 1" thick XPS is R5. It is not known if the insulation extends horizontally, however, it is assumed that it extends vertically downward from grade to a depth of 2' (The depth of the thickened edge slab noted on drawing).

- a. Add minimum R10 rigid XPS foundation insulation Note that the extent and depth of horizontal insulation should be confirmed and, if required, be supplemented to achieve nominal R20 or greater insulation value.

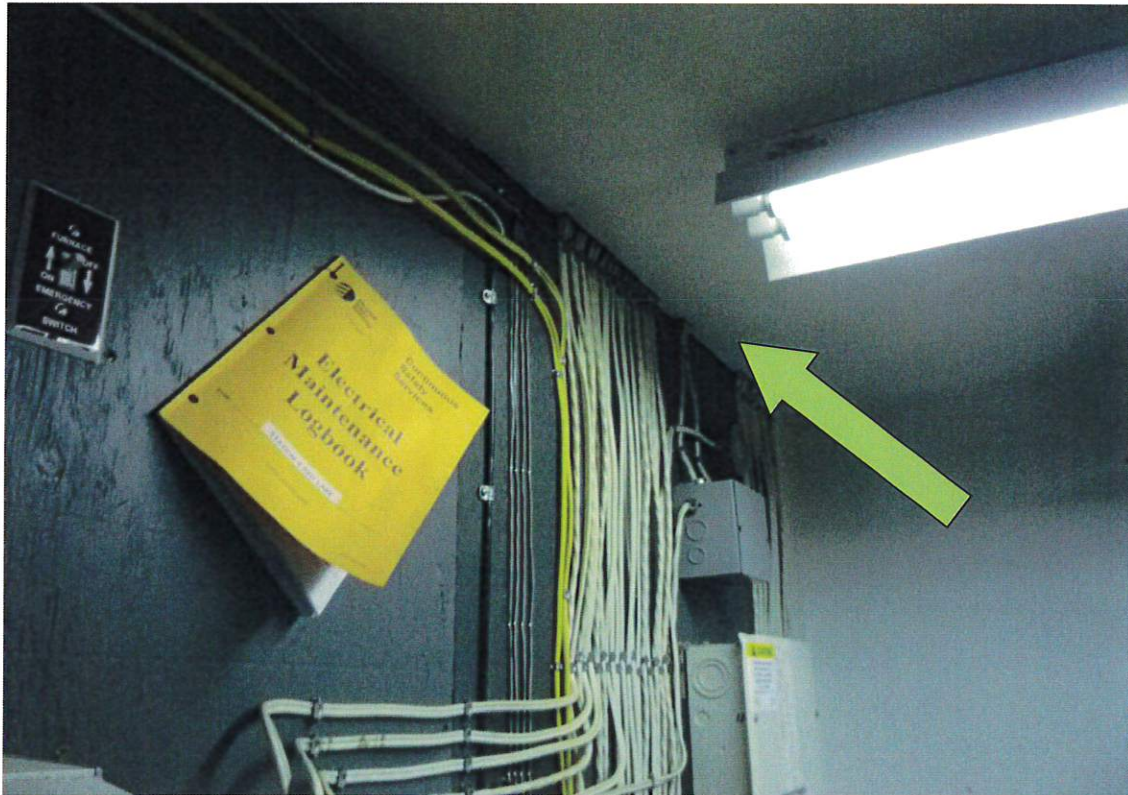
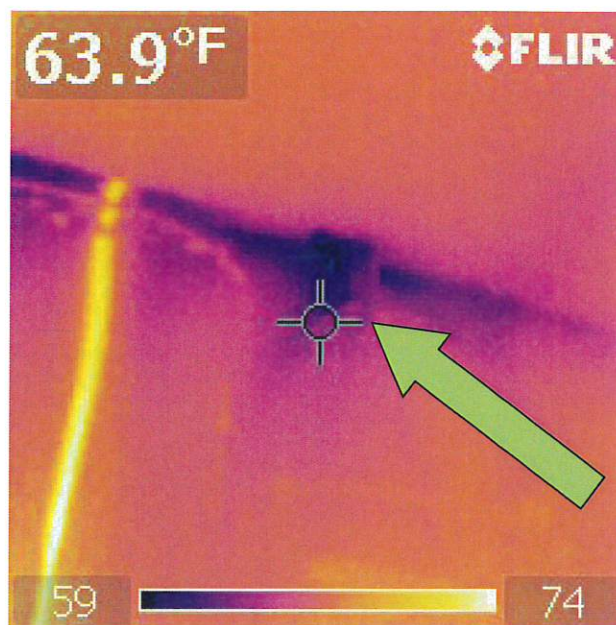
Air leakage observed at ceiling penetrations around wiring (photo above and image right)

- i. Overhead Doors
- ii. Man Doors
- iii. Attic Access Hatch
- iv. Vent Stack Penetrations (in attic)
- v. Duct Ceiling Penetration (in attic)
- vi. Wire Penetrations (in attic)

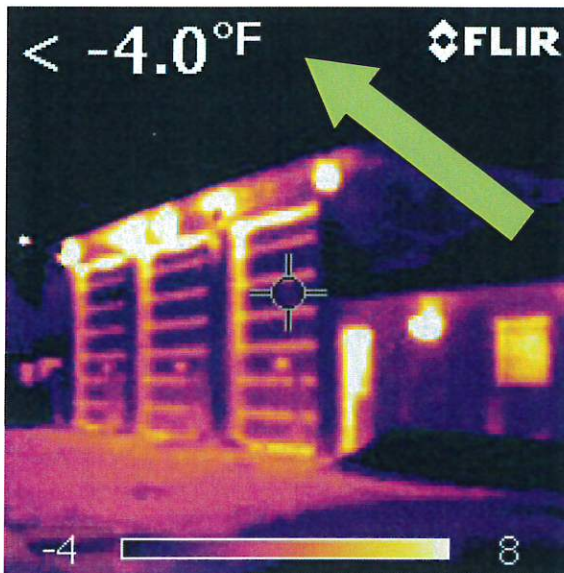
Exterior man-doors are insulated steel units (commercial). Weather stripping is worn and due for maintenance/repair. Air leakage evident in the infrared images (photo right). Estimated nominal insulation value is estimated at R2.

a. Replace, install or adjust weather stripping:

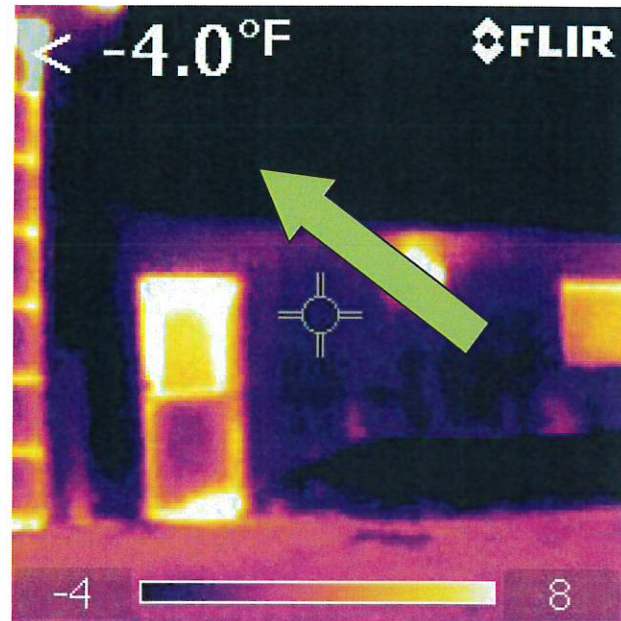
in the infrared images (photo left).

Overhead doors were found to be in need of adjustment at the head and sill locations. Past attempt to correct this condition were previously made, however, with limited success. Additional investigation into cause is recommended. Discontinuities in the air/vapour barrier system is suspected along the front garage wall. Significant leakage is evident

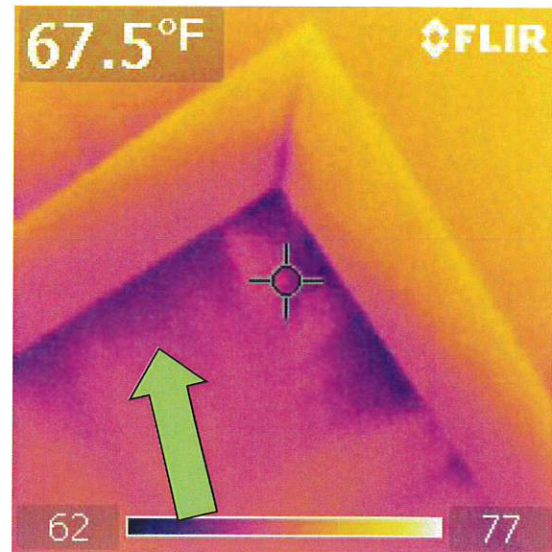
Access to the lower attic space was obtained through an interior access through the ceiling. The attic access does not fit the opening tightly and lacks weather-stripping. Air leakage is evident in infrared imaging (image right).

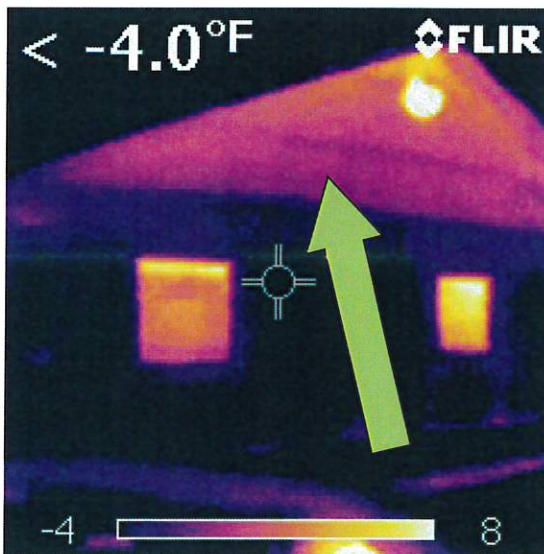
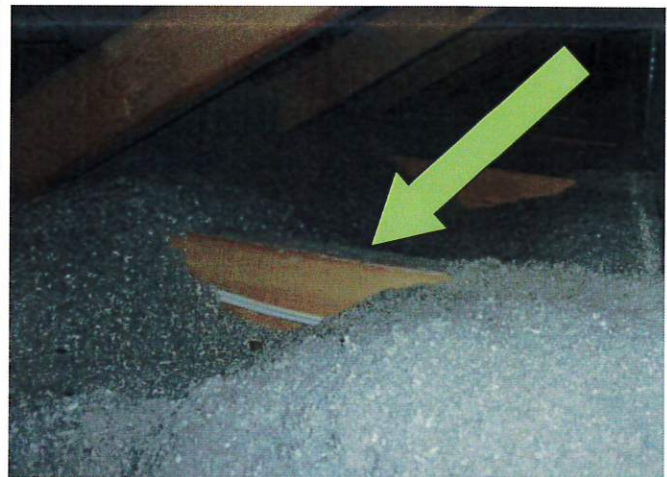
The roof/attic assembly consists of engineered wood trusses with metal sheathing over strapping. The attic floor is insulated with blown cellulose. The bottom chords of the trusses are visible (photo below right) and the average depth of

insulation is approximately 6" resulting in a nominal insulation value of R20. The effective insulation value is estimated at R19.

Heat loss from the attic is evident in infrared imaging (photo above).

- a. Add cellulose blown in insulation to achieve R60 nominal insulation value.
- b. Note that only after all measures have been made to ensure that the attic floor and any penetrations are sealed can additional insulation be added. Prerequisites also include determination of the scope of ductwork revisions (per above) and preparations for ensuring proper eave ventilation are maintained. A significant gain in energy savings is expected with this upgrade.

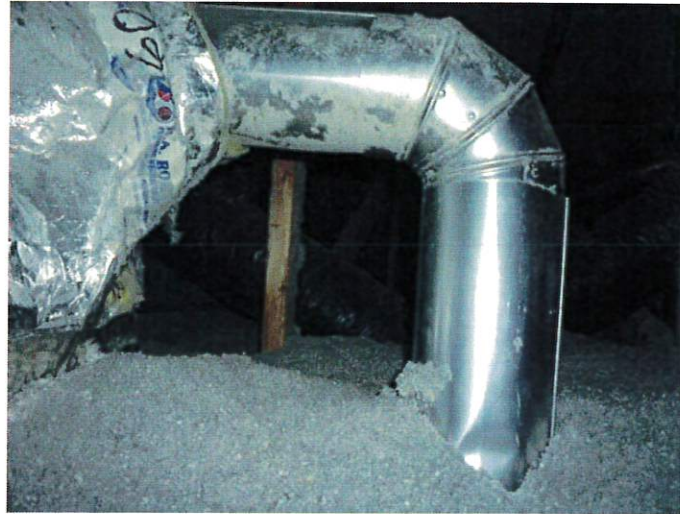
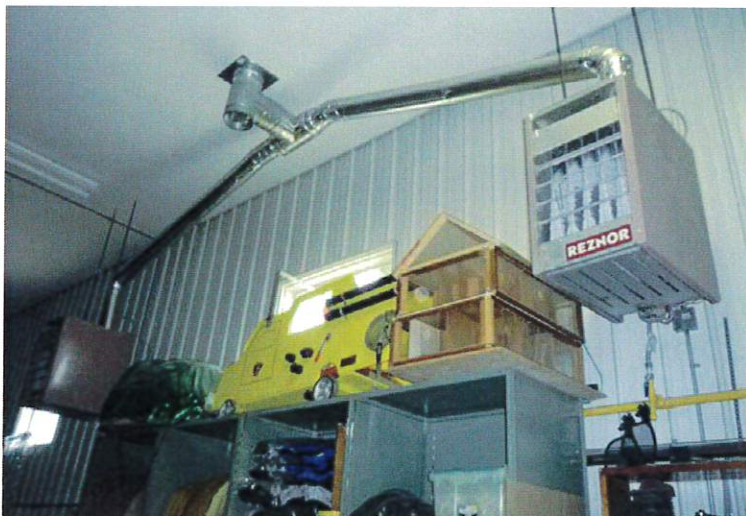
All primary air distribution and exhaust ducts are present in the lower attic space (photo right). Exposed ductwork is located above the insulation in the unheated zone outside the building thermal control layer. Minimal duct insulation is present at some locations; however, does not provide

appreciable benefit or resistance to heat-loss. The ductwork is poorly supported/fastened and not sealed. Generally, for the given climate zone, placement of ducting in the unheated attic space, especially heating, should be avoided wherever possible.

- d. Revise Ductwork
 - i. Option 1 - Relocate ductwork to interior (preferred option).
 - 1. Design new ductwork to suit airflow requirements based on and in conjunction with proposed heating systems upgrade (see below).

- ii. Option 2 – Seal and insulate attic ducting.
 - 1. Less than optimum performance will be achieved with this option and the risk of moisture related issues which may occur in the future will increase and may be detrimental to occupant safety/comfort and/or building durability/performance. This option should only be considered if Option 1 cannot feasibly be implemented. If so, then stringent standards for implementation must be followed to ensure serviceability and durability of the structure.

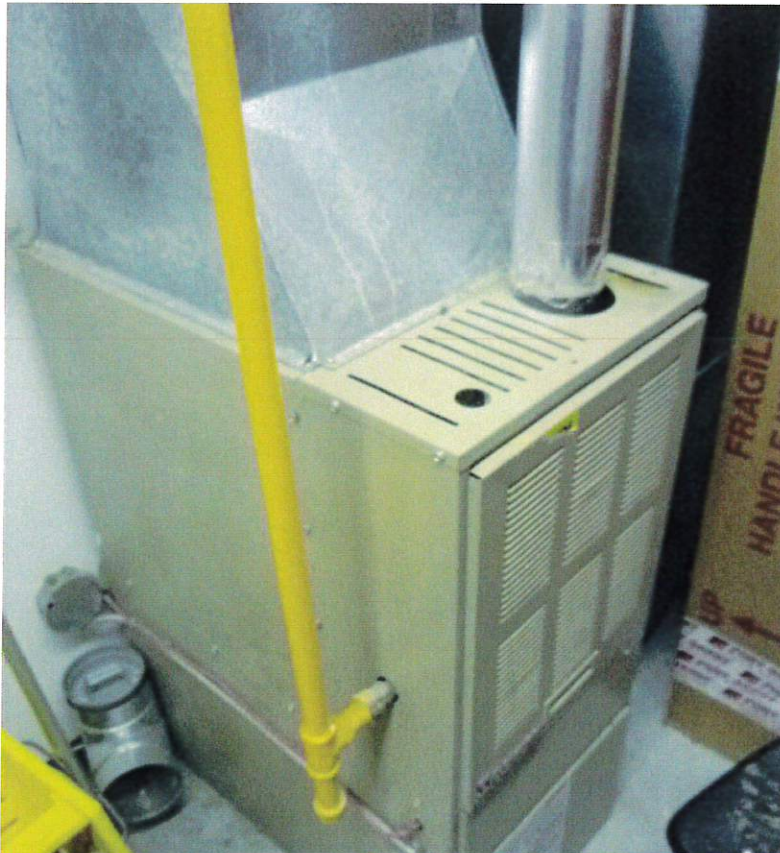
Separate heating systems are provided for the garage bays and the office/admin/training room areas. The garage bays are heated with two (2) ceiling suspended propane-fired fan/coil (1/30hp) unit heaters (photo left). These units

are naturally aspirated and vent to a common flue. Each unit has an input rating of 100,000 Btu/h (Model F100-3 by Reznor). These units have an estimated steady-state efficiency rating of 75%.

- a. Install a new natural-gas-fired condensing, direct-vented, forced-air furnace that is sized appropriately for the entire facility based on post-upgrade heat-loss analysis with an AFUE rating of 96.0 or greater.

- b. Install complete side-wall exhaust and intake flues (direct vents) for sealed combustion to eliminate back-drafting potential.
- c. Eliminate all vertical flues and ceiling penetrations.

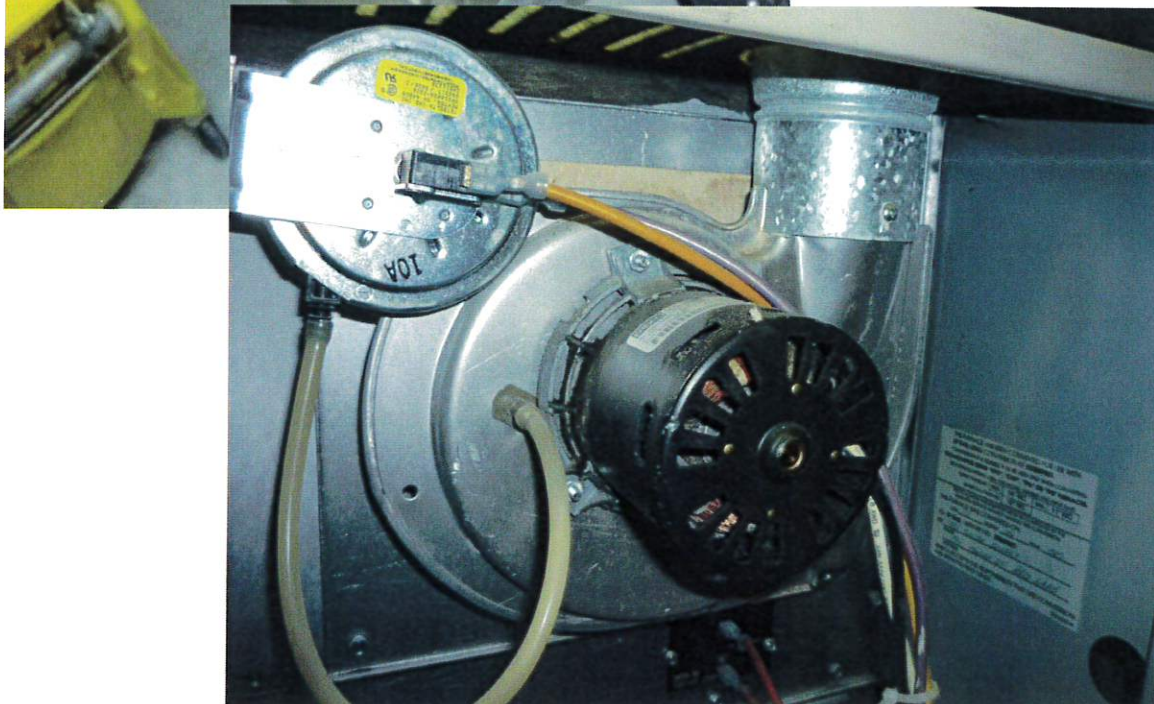
The admin area is heated with a propane-fired forced-air furnace rated at 100,000 Btu/h with an induced draft flue (Model NPGA100BA by Ducane, photo left and below). The flue is shared with the hot water tank. The estimated steady state energy efficiency rating of this unit is 82%.

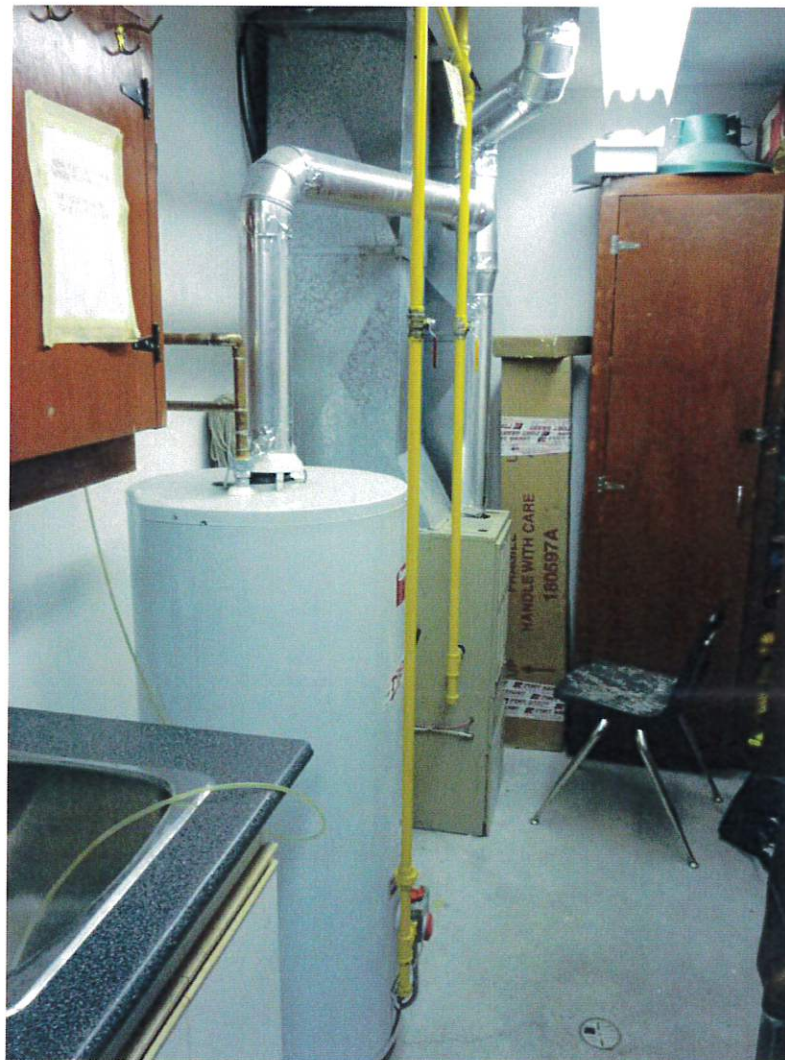
Domestic hot water is provided via a propane-fired, naturally aspirated storage-type hot water tank (41.6 Imp. Gal. by Giant, Model UG50-41LE-P, photo below). The existing hot water tank has an estimated Energy Factor (EF) of 0.55.

- f. Replace Domestic Hot Water System
 - a. Install a new DHW system with a condensing, direct-vent tank-less natural-gas-fired hot water heater with an Energy Factor of 0.90 or greater.
 - b. Install complete side-wall exhaust and intake flues (direct vents) for sealed combustion to eliminate back-drafting potential.
 - c. Eliminate all vertical flues and ceiling penetrations.
- g. Upgrade Lighting
 - a. Install LED lighting.
 - b. Install motion/occupancy sensors/timers.

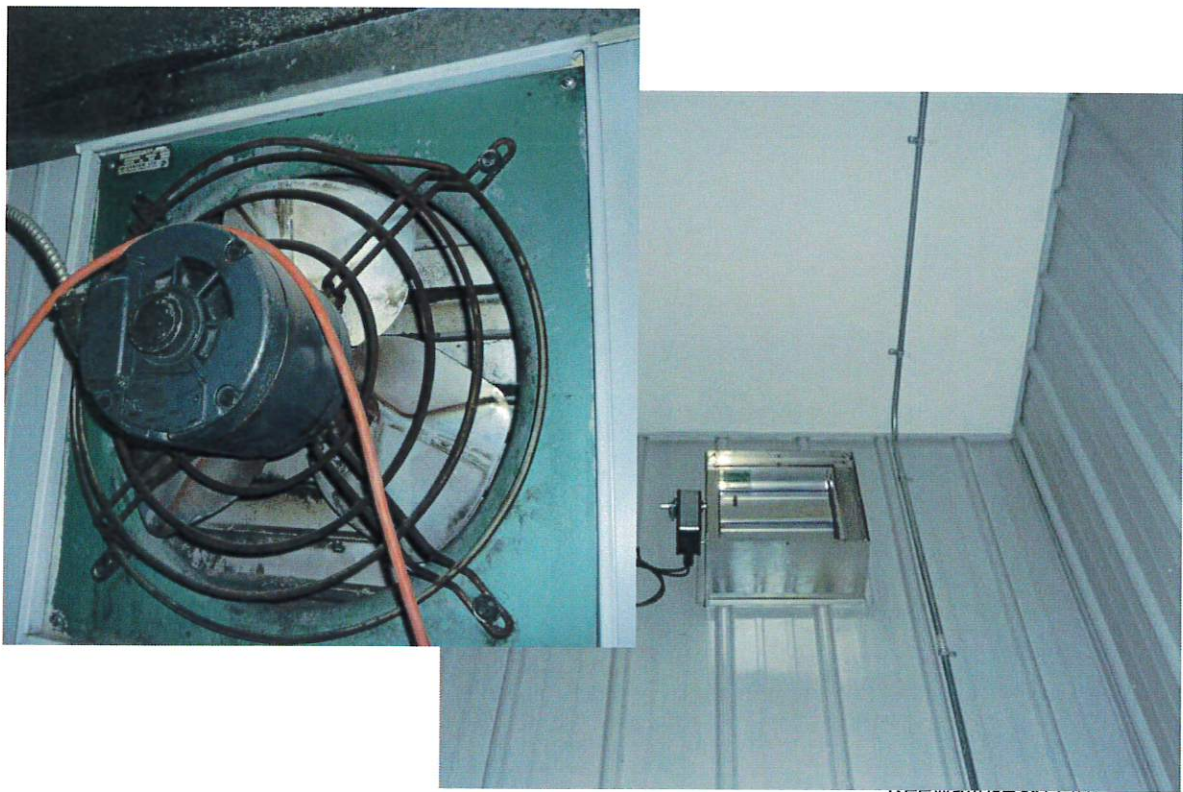
Carbon monoxide sensors are present in the garage area and automatically engage an exhaust fan to eliminate fumes after vehicles enter/exit the space. The exhaust fans (photo below, top) are interconnected with motorized dampers (bottom photo) to allow fresh air in and minimize or eliminate back-drafting of the fuel-fire appliances.

Exhaust depressurization revealed that the building pressure can be reduced to -25Pa when all exhaust fans are activated. The pressure is maintained for a short period while the motorized damper opens. Given the presence of naturally aspirated heating and hot water appliances in the facility it is probable that, at times, the exhaust fan can cause back-drafting condition. As a result, the rising carbon monoxide levels may trigger the CO sensor and cause the exhaust fan to operate for extended periods resulting in a further energy penalty.
