**Reference: Howey Bay Road Bridge and Forestry Road Culvert - OSIM Bridge Inspections 2023  
Summary Letter**

## Howey Bay Road Bridge Inspection

# 2023 OSIM Visual Inspections Howey Bay Bridge 2023-11-22

**Structure Name:** Howey Bay Bridge  
**Structure Type:** Steel Girder  
**Year Built:** Unknown  
**Yr. of Last Rehab:** 2021

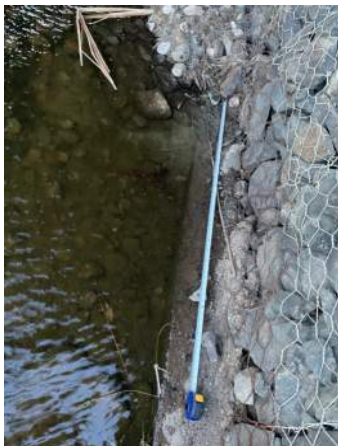
Slope Protection - SU1. Note: Typical holes in gabion wires.

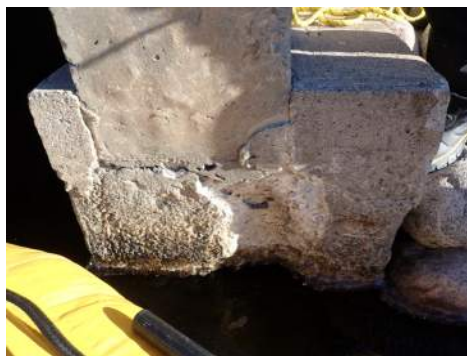
Inlet - SW corner. Note: Disintegration of footing

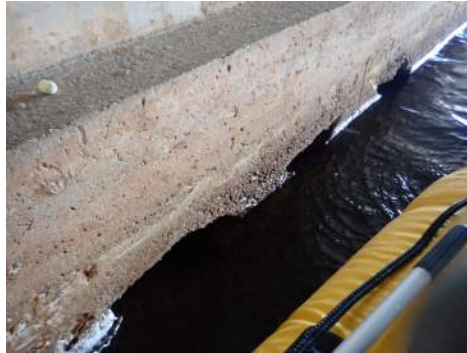
Footing - South wall near midspan. Note: Typical disintegration and exposed rebar
