Balmertown Fire Station

Energy Efficiency Evaluation, 10044

FINAL REPORT - JULY 2012

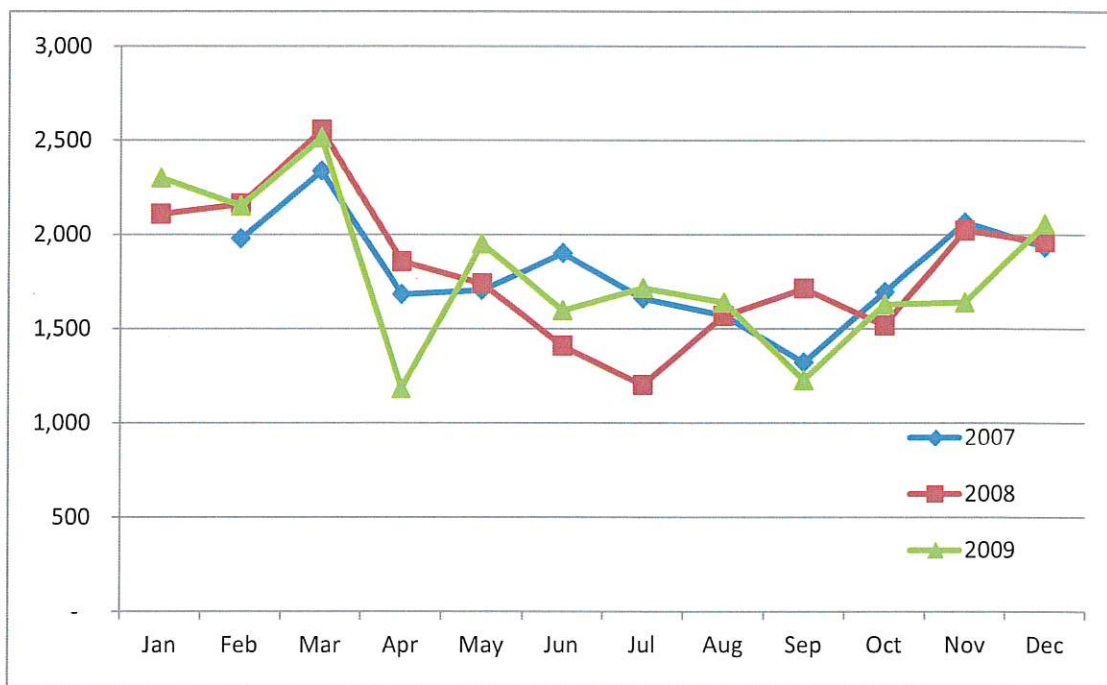
Figure 1 - Monthly HYDRO Consumption Data (kWh)

The average annual hydro usage is 20,300 kWh (72.9 GJ) based on a three-year consumption history (2007 to 2009). Generally usage is consistent through the year with a moderate peak annually in March. Average monthly hydro usage¹ is approximately 1700 kWh as shown in Figure 1 below. Key electrical consumption loads are lighting, ventilation, fans/motors, battery chargers, business/admin equipment.

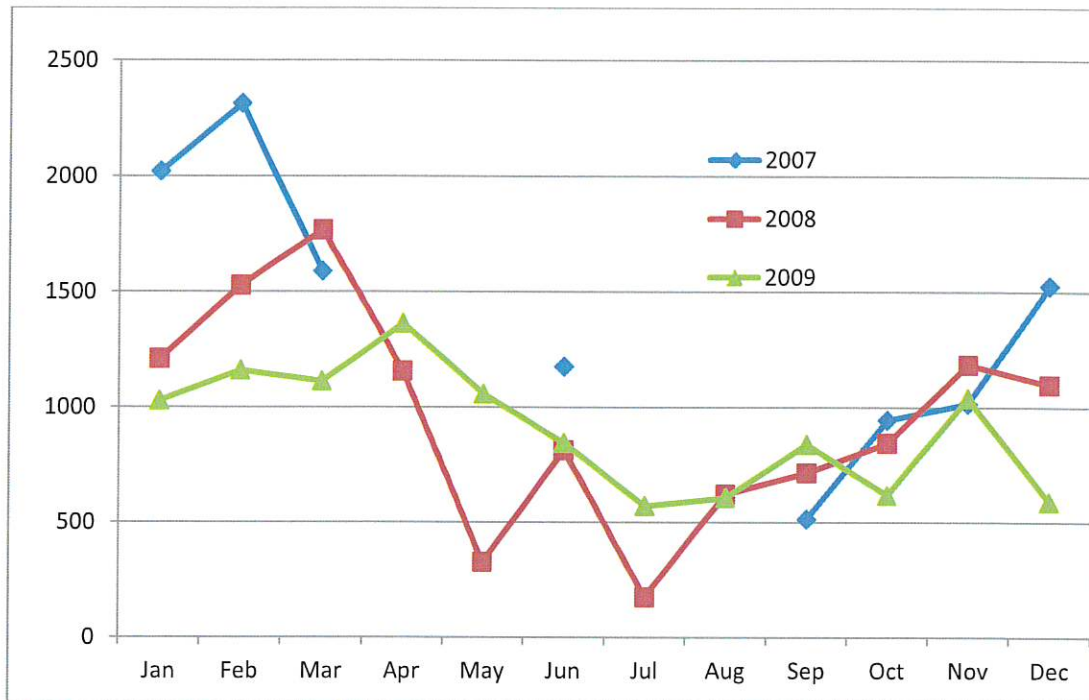
Figure 2 - Monthly PROPANE Consumption (litres)

The average annual propane usage is 11,127 litres (281.6 GJ or 78120 ekWh²) based on a three-year consumption history (2007 to 2009). Key propane consumption loads are heating and domestic hot water.

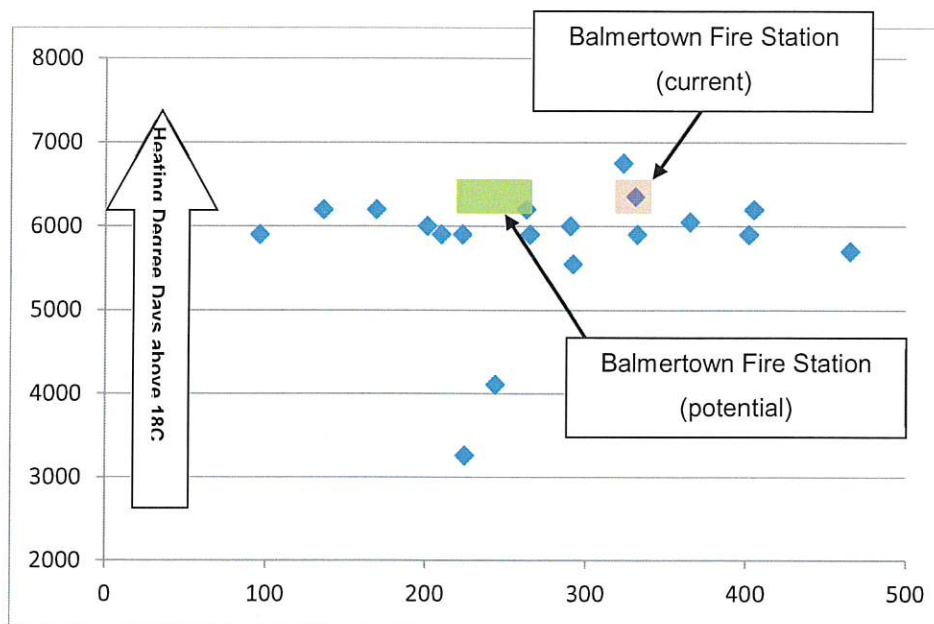
Figure 3 - Energy Intensity (ekWh/m²) Comparison of Similar Facilities³

The total energy consumed annually is 354.5 GJ and the building area is 298 m² which equates to an Energy Intensity of 1.19 GJ/m² (330.8 ekWh/m²). Approximately 14% higher than the average intensity of 290 ekWh/m².

Figure 3 above illustrates a comparative ranking for a representative sample of similar facilities (Municipal Fire Halls) in Ontario and Manitoba based on pre-retrofit conditions.

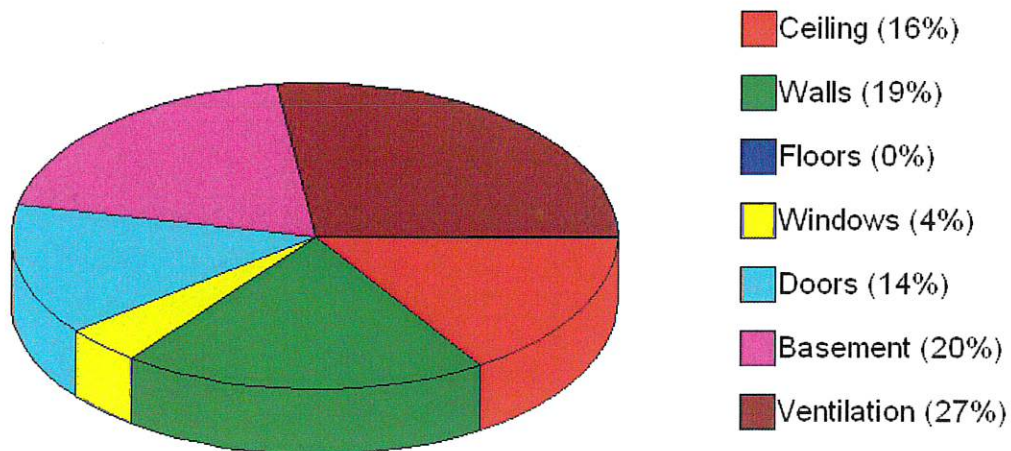
Figure 4 - Components of annual heat loss.

Figure 4 on the next page represents the estimated relative energy losses for the primary building enclosure and mechanical assemblies or systems comprising the Balmertown Fire Station.

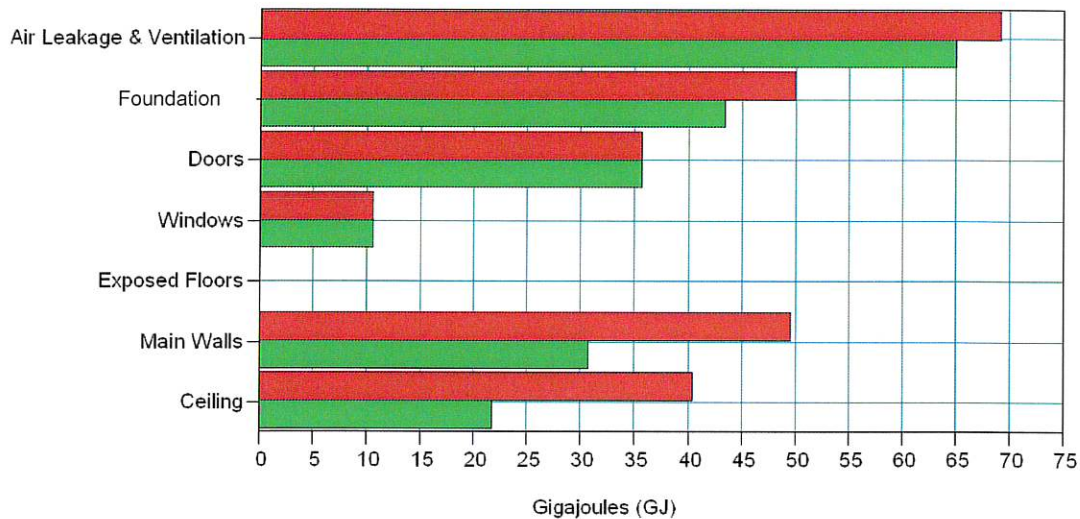
Figure 6 - Breakdown of Heatloss Through Building Enclosure

In Figure 6 above, the various components of heat loss are presented. The air leakage component is added to illustrate the separate impact of the combined air leakage (convective heat loss) characteristics from the remaining assemblies. Pre-retrofit values are indicated in *red (top bar)* while post-retrofit values are shown in *green (bottom bar)*. The effects of the proposed energy saving measures, if implemented as whole, are illustrated. It is noted that air leakage is the single highest factor responsible for 28% of the estimated total energy loss, followed by losses through the foundation and walls at 17% and ceiling at 14%.

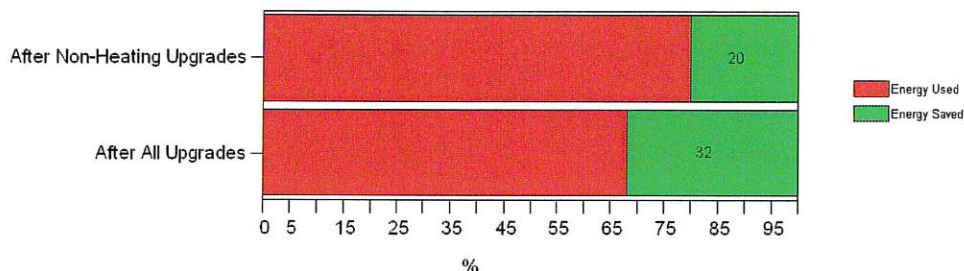
Figure 7 - Estimated Percentage of Potential Energy Savings

As shown in Figure 7 below, the overall potential of energy savings is 20% (after non-heating upgrades) and a further 12% for a total of 32% by implementing the recommended upgrades.
