**Reference: Howey Bay Road Bridge and Forestry Road Culvert - OSIM Bridge Inspections 2023  
Summary Letter**

## Howey Bay Road Bridge Inspection

# 2023 OSIM Visual Inspections Howey Bay Bridge 2023-11-22

**Structure Name:** Howey Bay Bridge  
**Structure Type:** Steel Girder  
**Year Built:** Unknown  
**Yr. of Last Rehab:** 2021

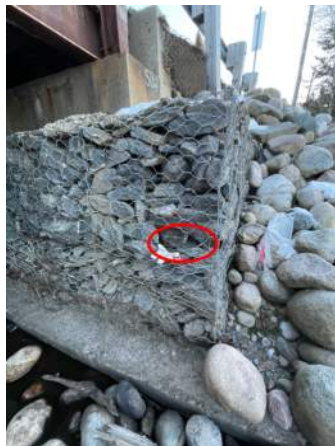
Slope Protection - SU2. Note: Typical holes in gabion wires.

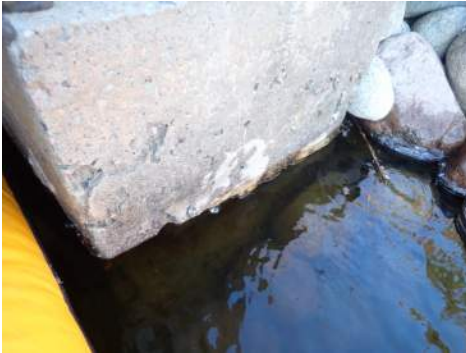
Outlet - NE corner. Note: Disintegration of concrete footing below waterline.
