**Building Condition Assessment
(BCA)**

BCA Report for Cochenour Arena

10 William St.

Report Date
July 14, 2022

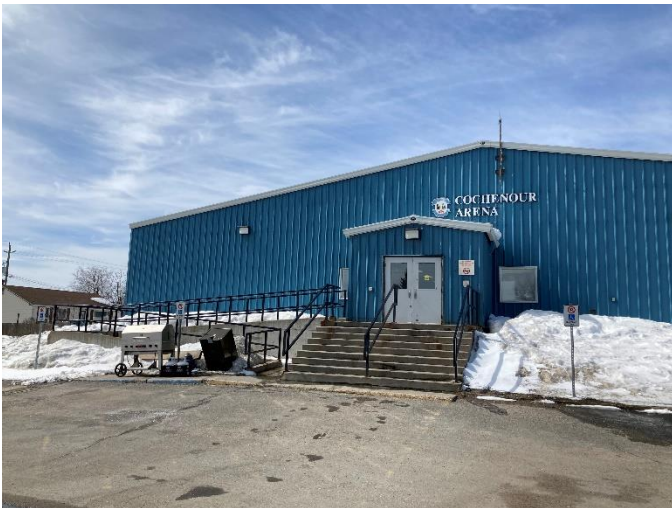
Figure 1 - Arena exterior with entry stair and ramp

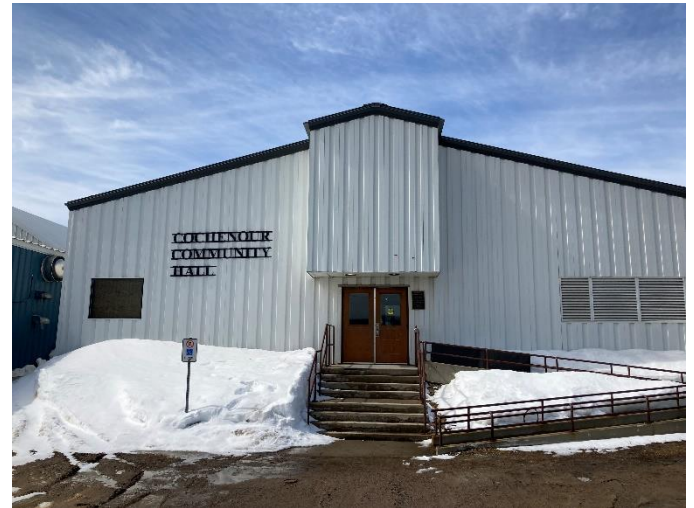
Figure 2 – Community Centre exterior with entry stair and ramp

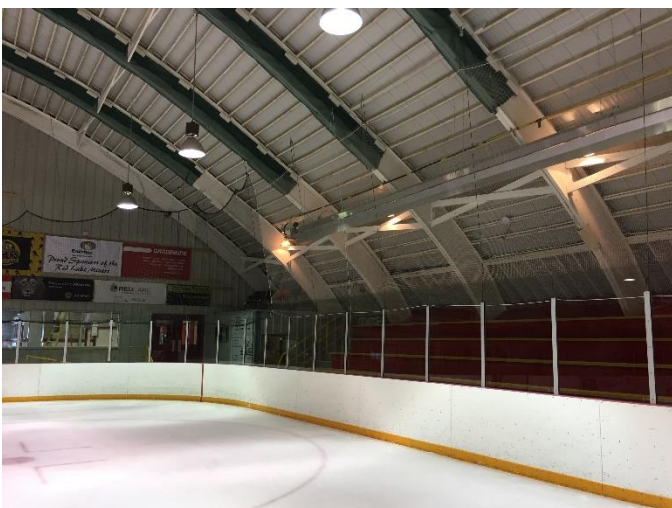
Figure 3 –Rink , dasher boards and spectator stands

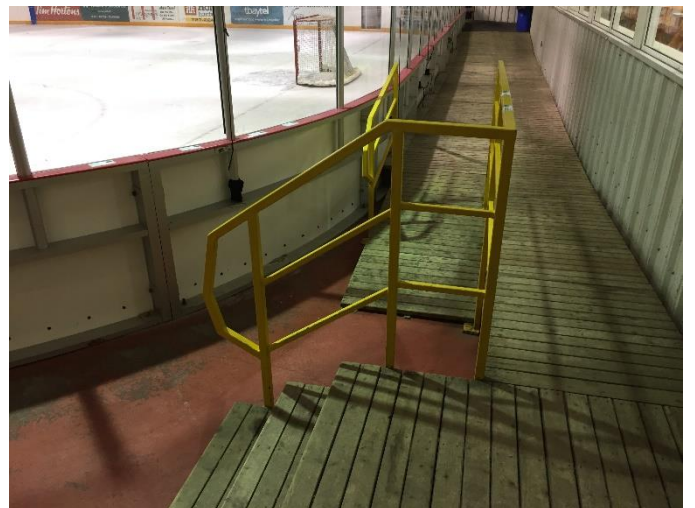
Figure 4 – ramp into rink from Foyer

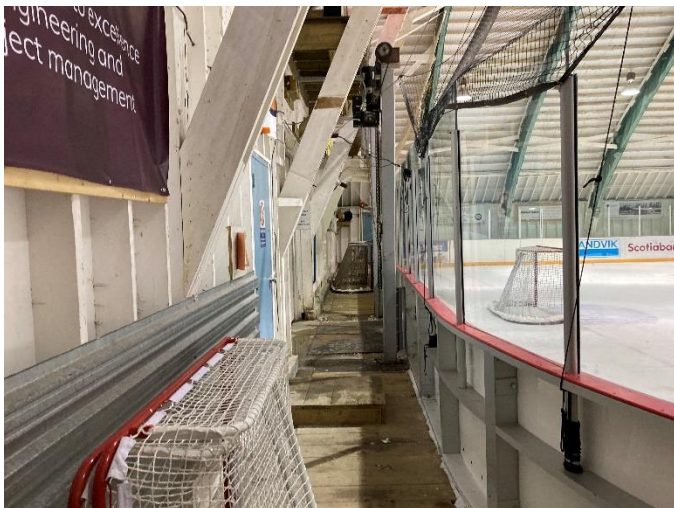
Figure 7 – cover over header trench for chilled slab and access to ice plant

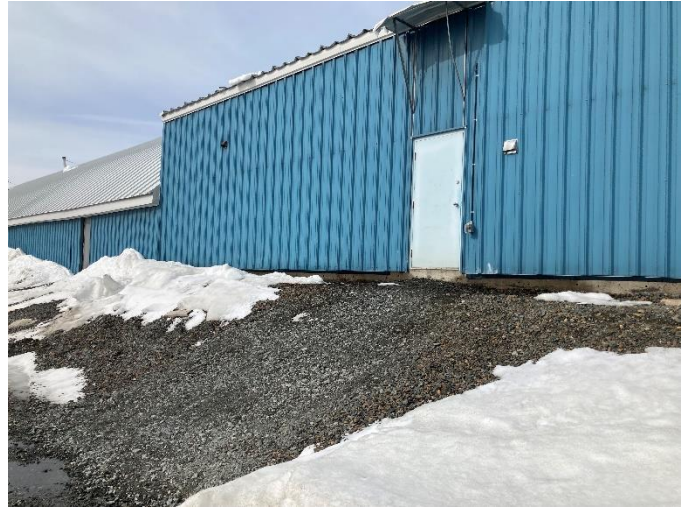
Figure 10 – exit from kitchen not meeting accessibility requirements

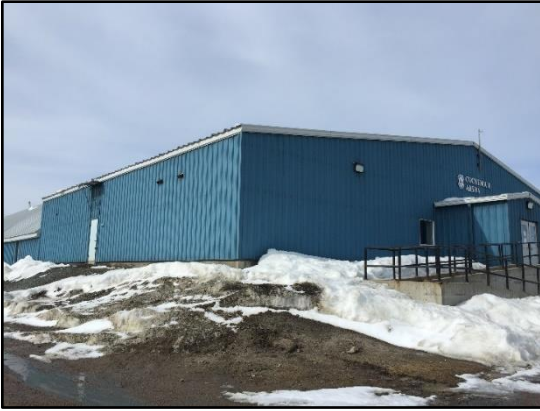
Figure 1 – Overall picture of the Cochenour Arena

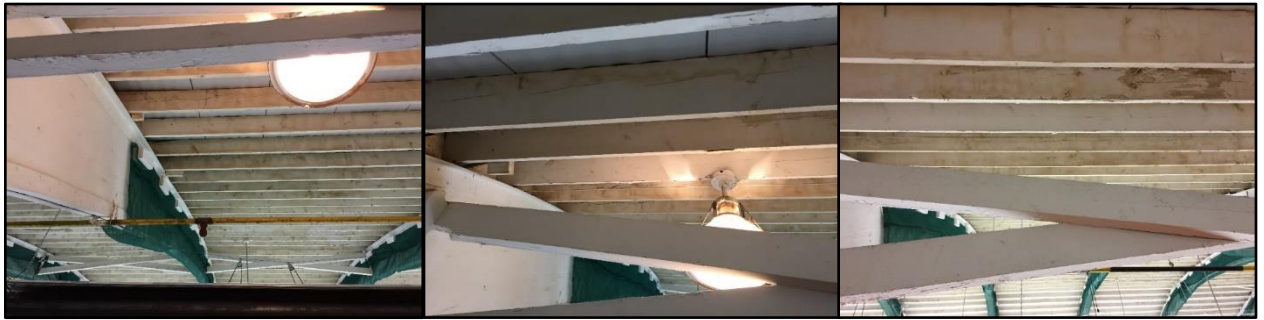
Figure 4 – Wood purlins in the arena

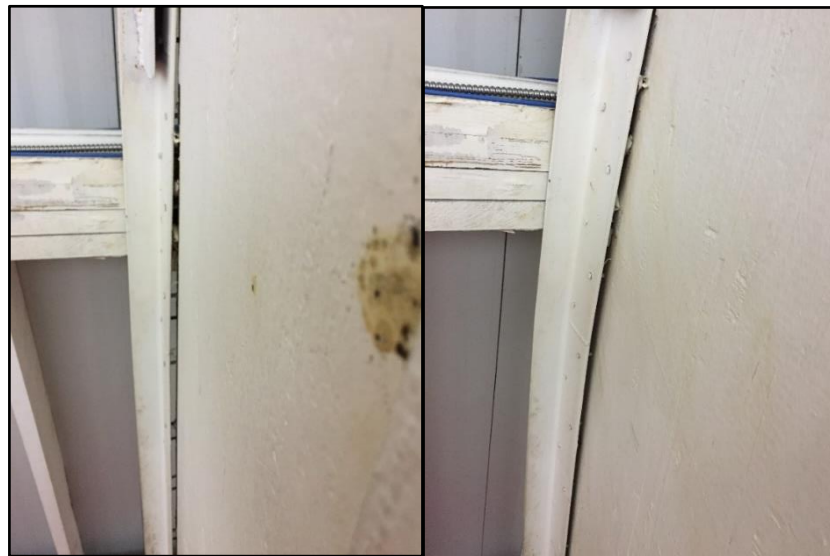
Figure 5 – Fastening of angles on Glulam beams

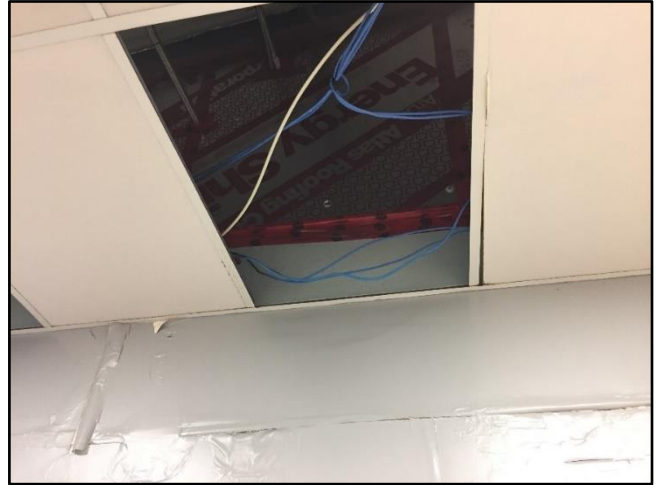
Figure 13 – Insulation at the wall
between Hockey Arena and
Reception Area

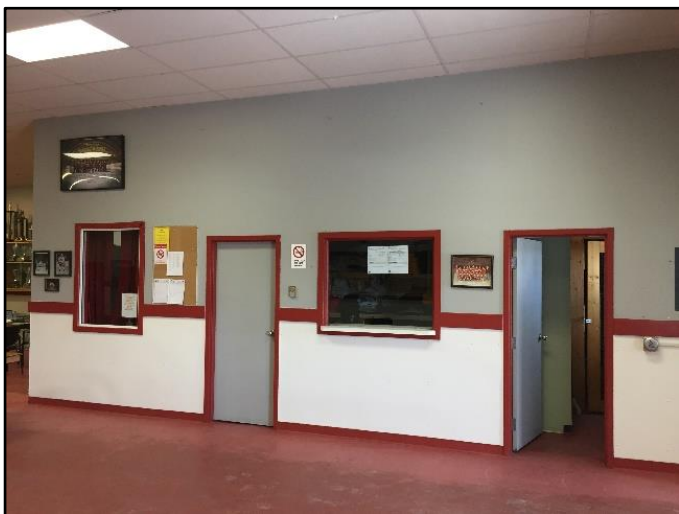
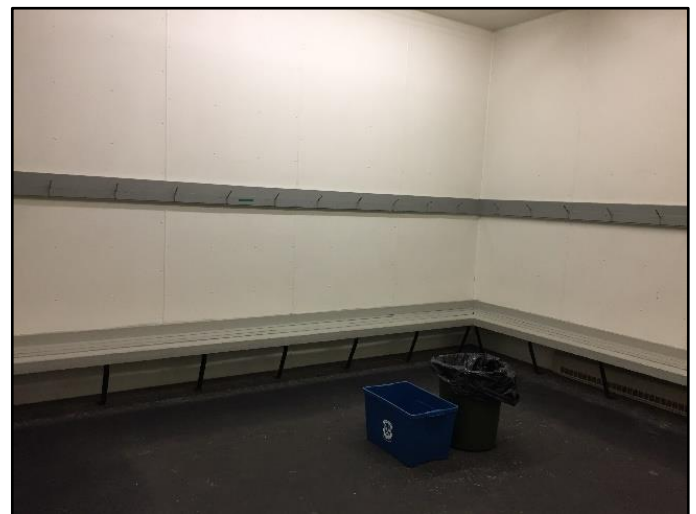
Figure 16 – Reception Area (Left), and Dressing Rooms (Right)

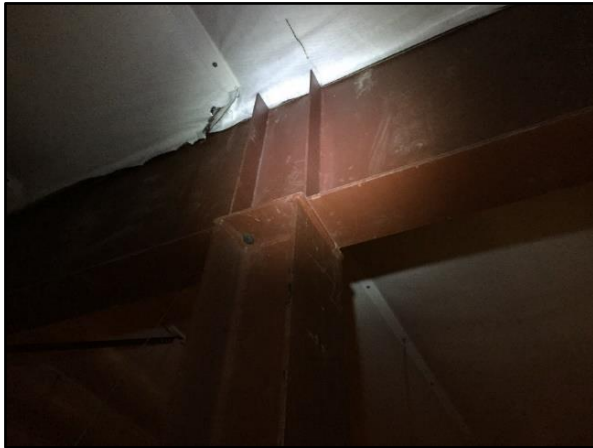
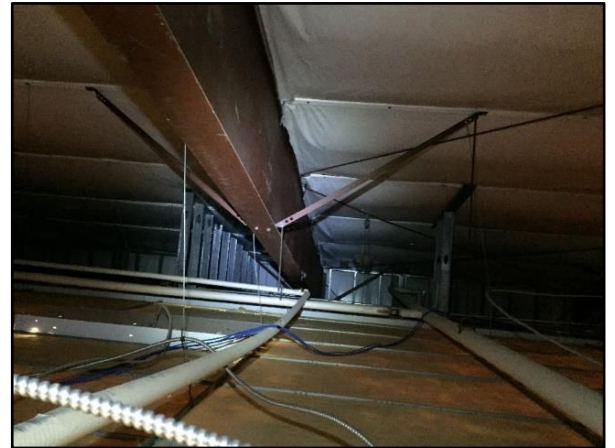
Figure 17 – Structural Steel Framing in the Reception Area

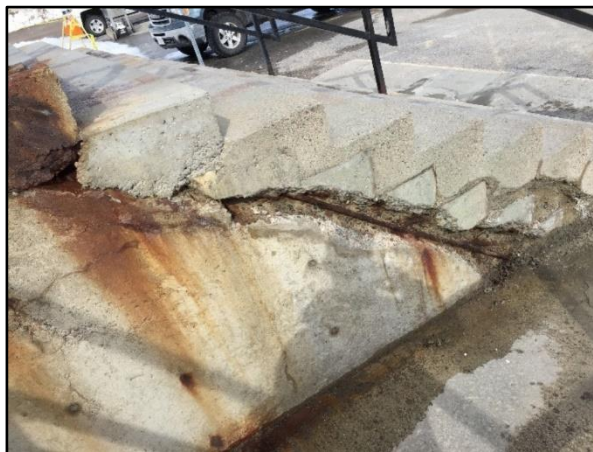
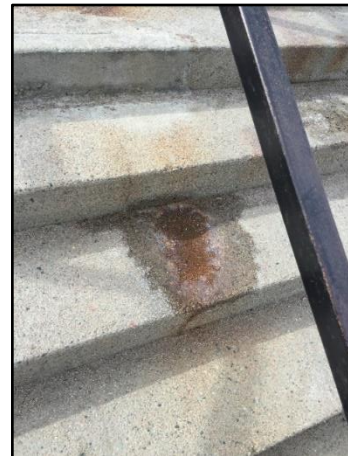
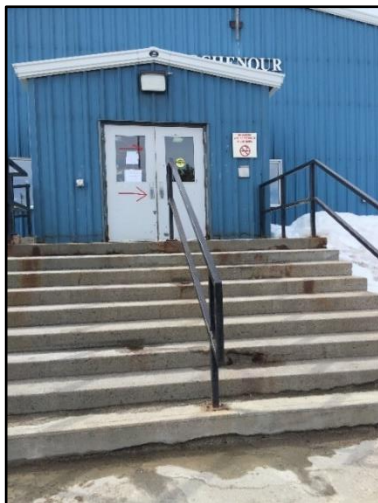
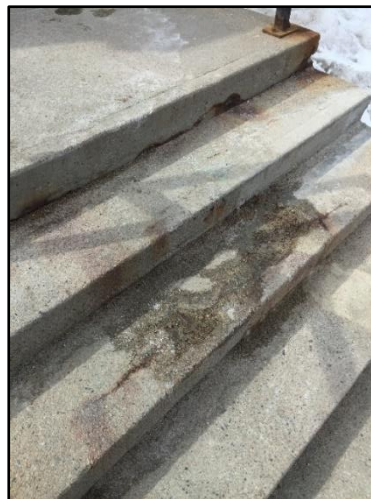
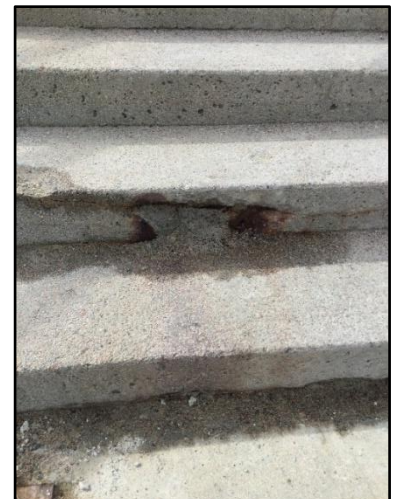
Figure 18 – Stairs at the Entrance of the Reception Area

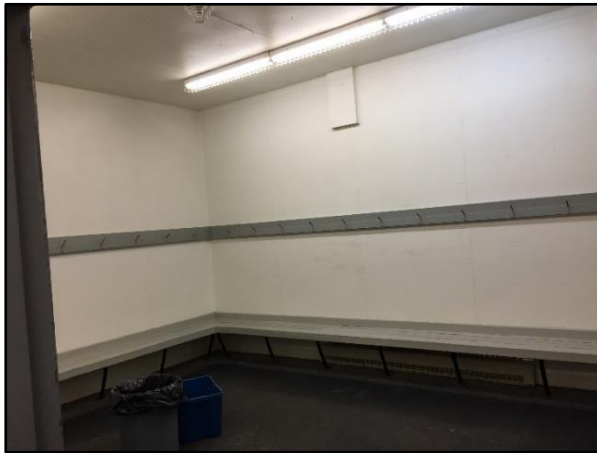
Figure 21 – Dressing rooms area

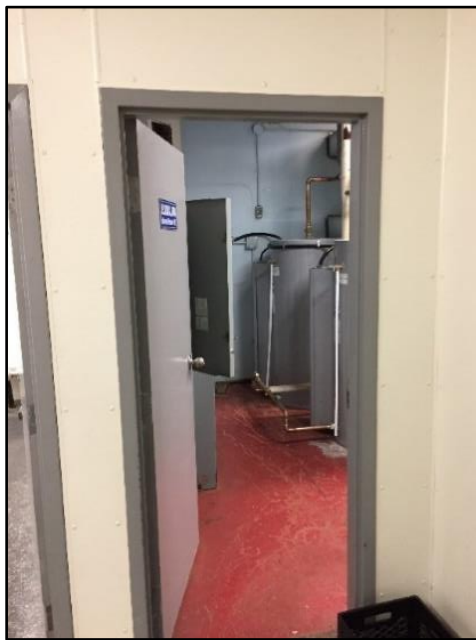
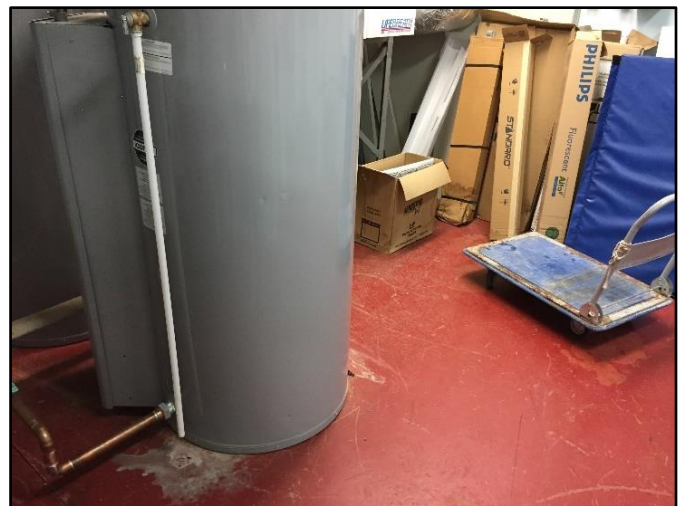
Figure 22 – Concrete floor in Mechanical

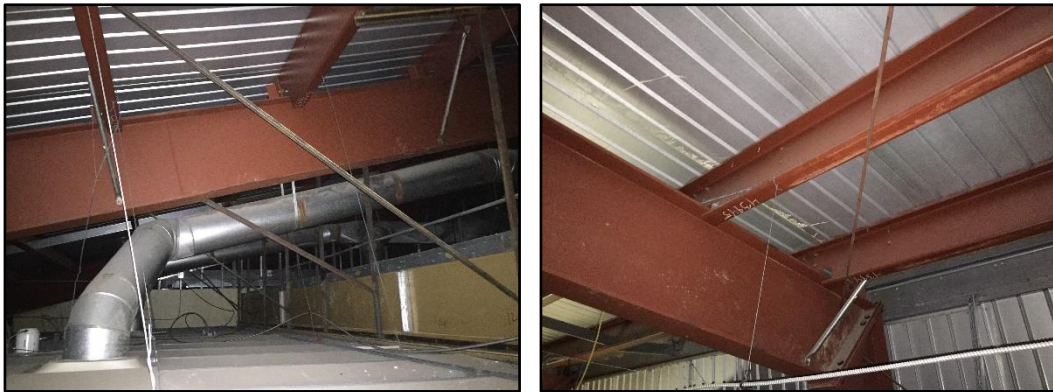
Figure 24 – Structural Steel Framing in the Community Hall

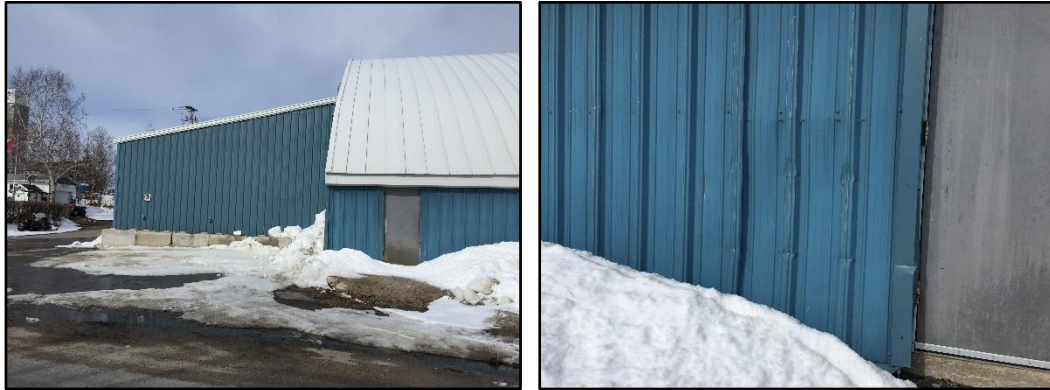
Figure 26 – Exterior of Arena

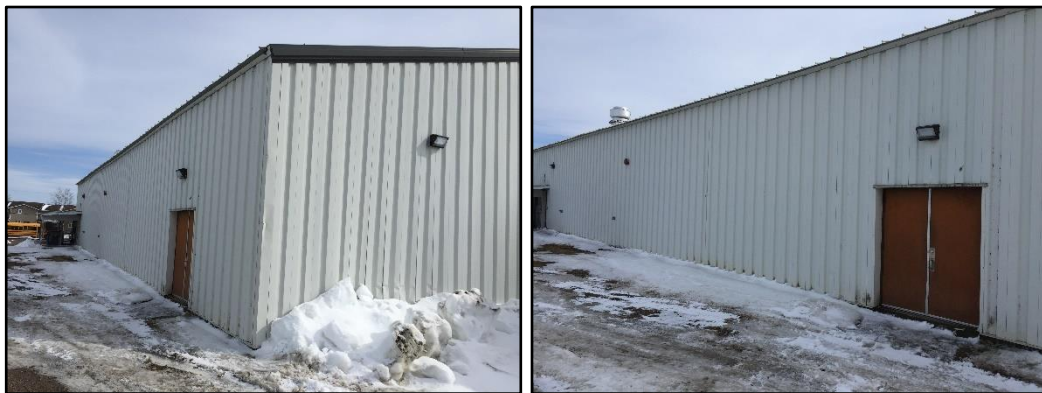
Figure 27 – Exterior of Community Hall

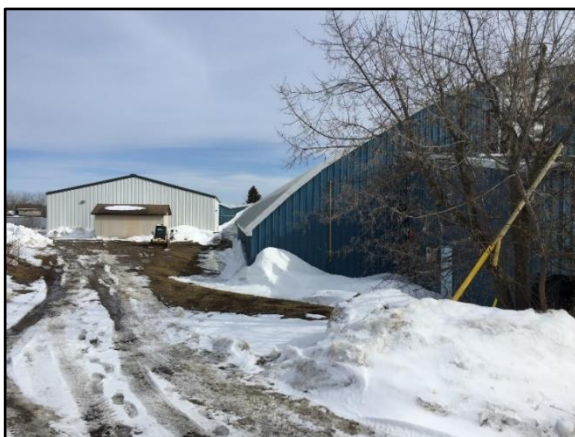
Figure 28 – Ground slopes towards north wall of the arena room slab.

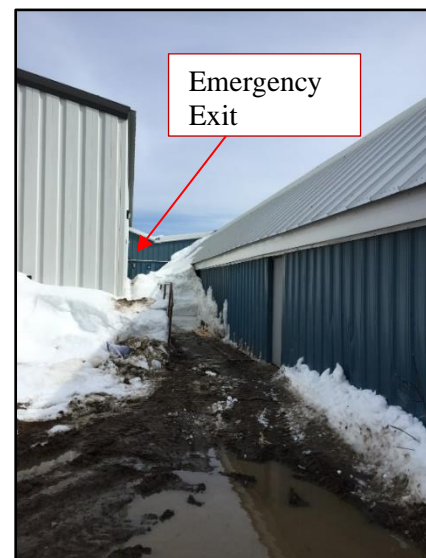
Figure 29 – Emergency exit from the community hall is blocked with snow

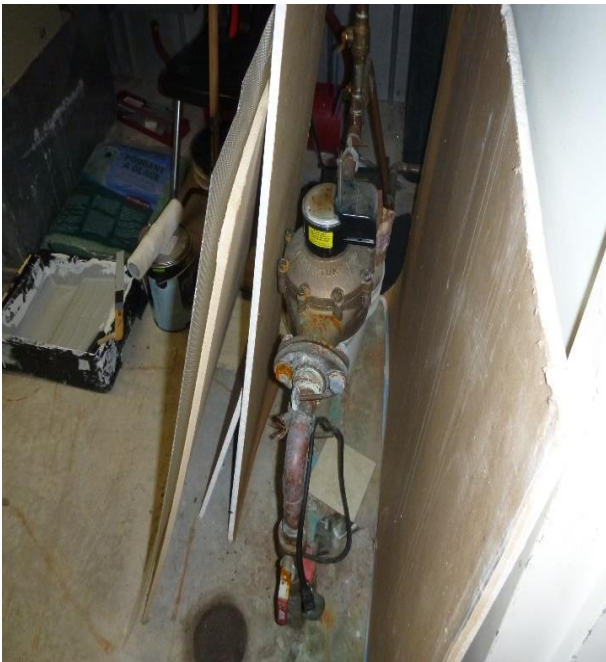
Figure 1 - Community Hall's 1-1/4" domestic cold water

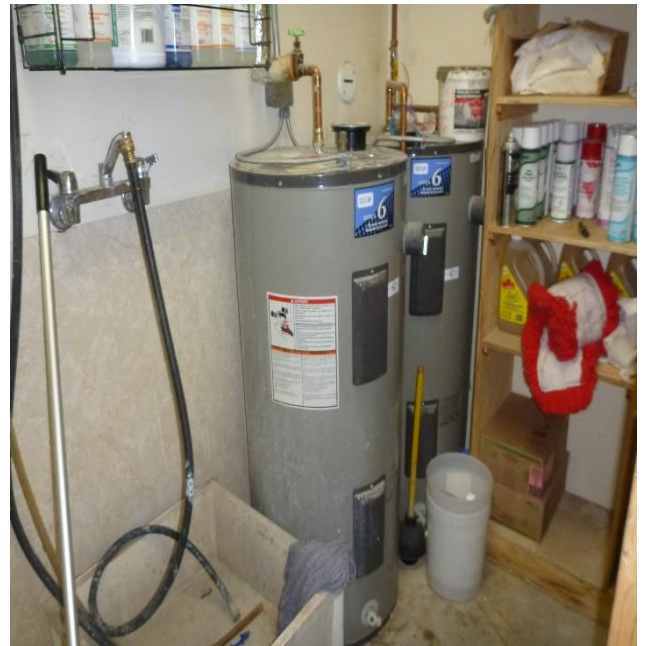
Figure 2 – Community Hall's domestic water heaters

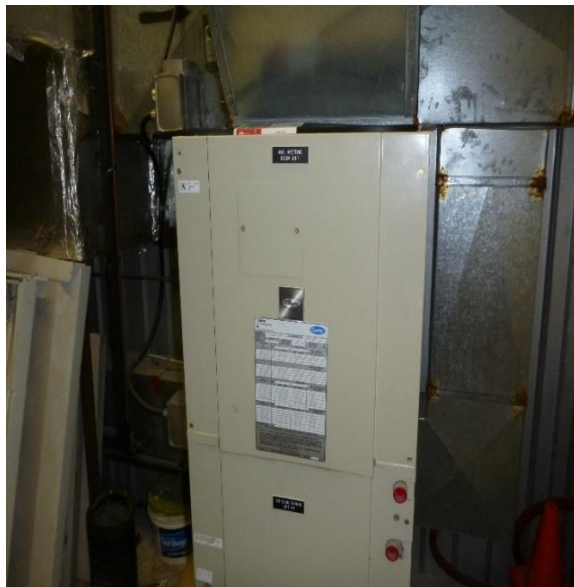
Figure 3 – Community Hall's AC Unit

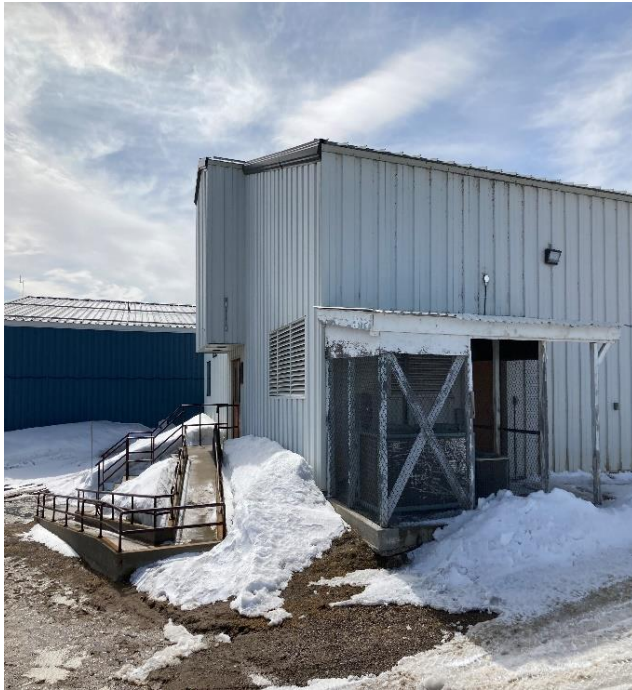
Figure 5 – Community Hall's condensing unit

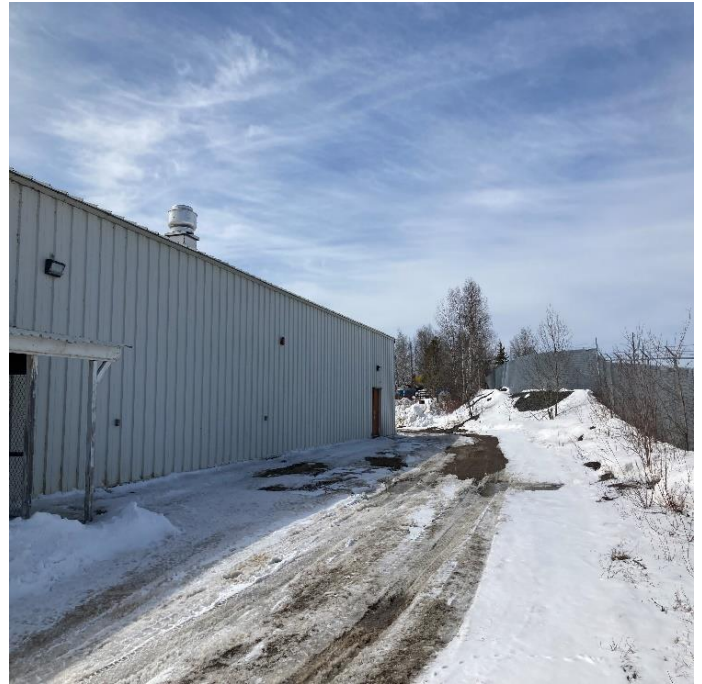
Figure 6 – Community Hall's roof - mounted kitchen exhaust fan

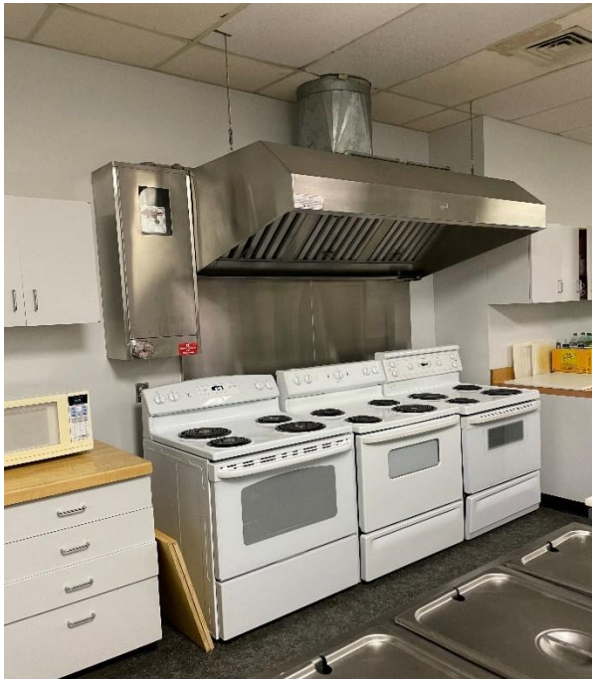
Figure 7– Community Hall's exhaust hood & fire suppression

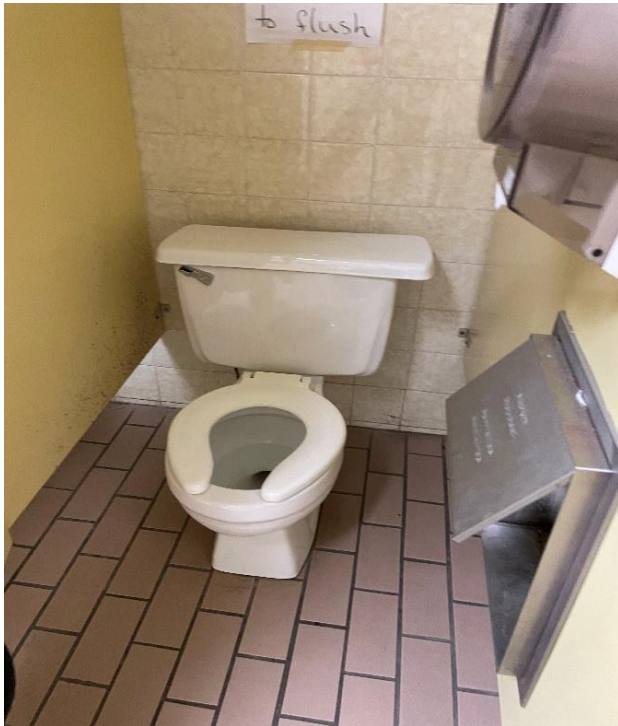
**Figure 9 – Typical Water closed in
Arena & Community Hall**

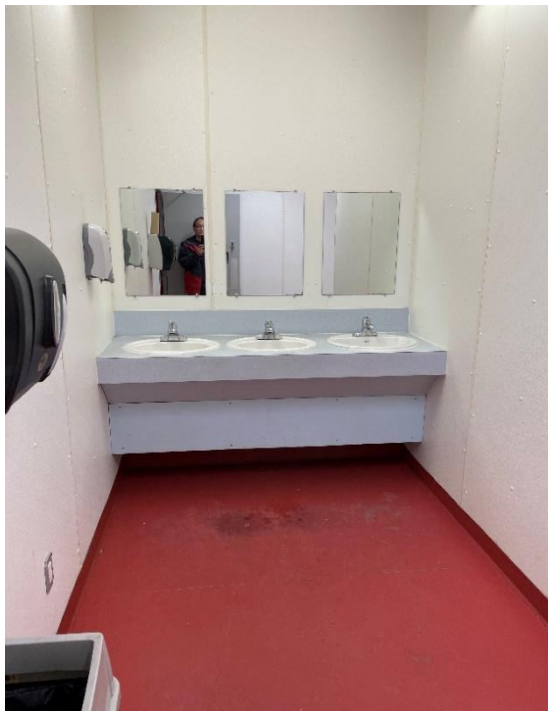
Figure 11 – Typical lavatories in Arena

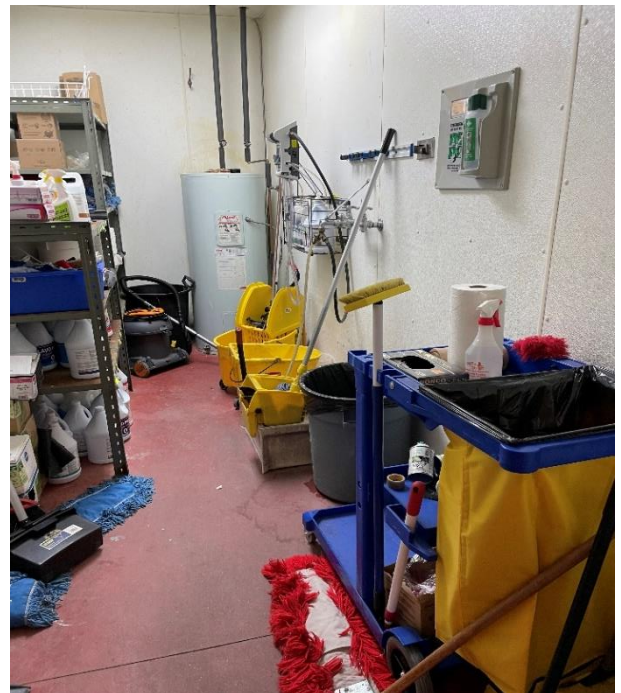
Figure 12 – Arena Hall janitor room

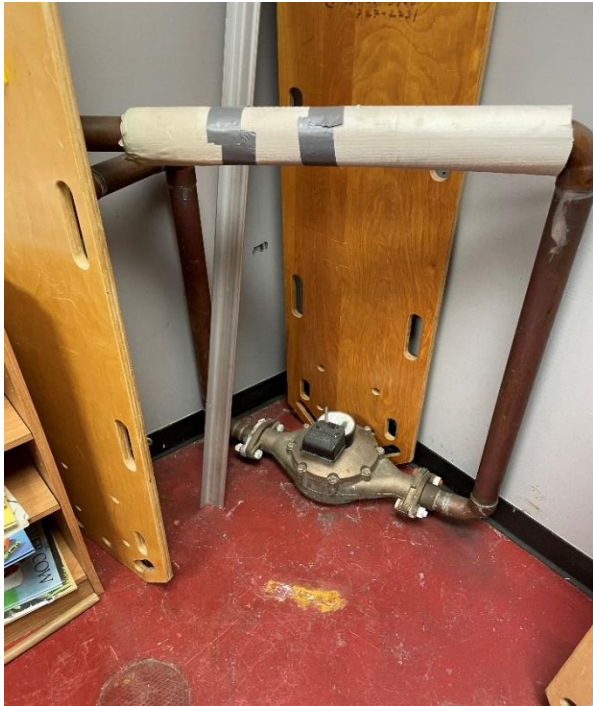
Figure 13 – Arena Hall's 2" domestic cold water supply

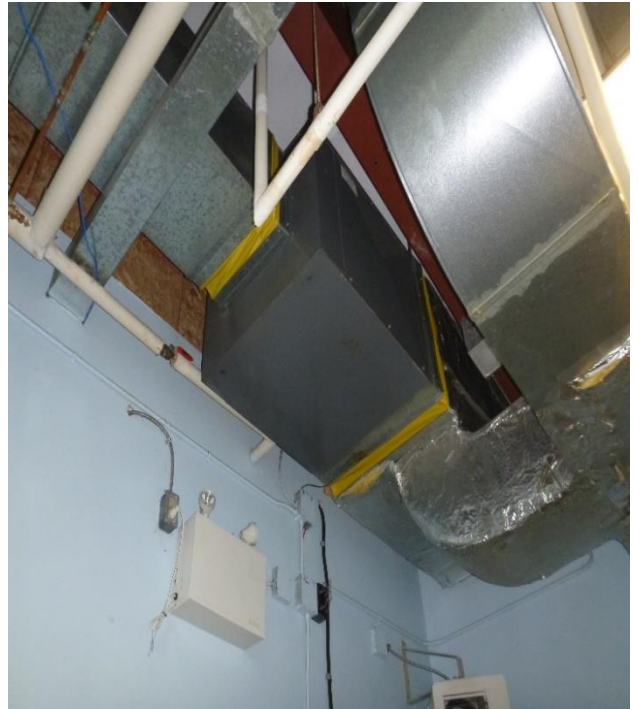
Figure 14 –Arena Hall's ventilation unit

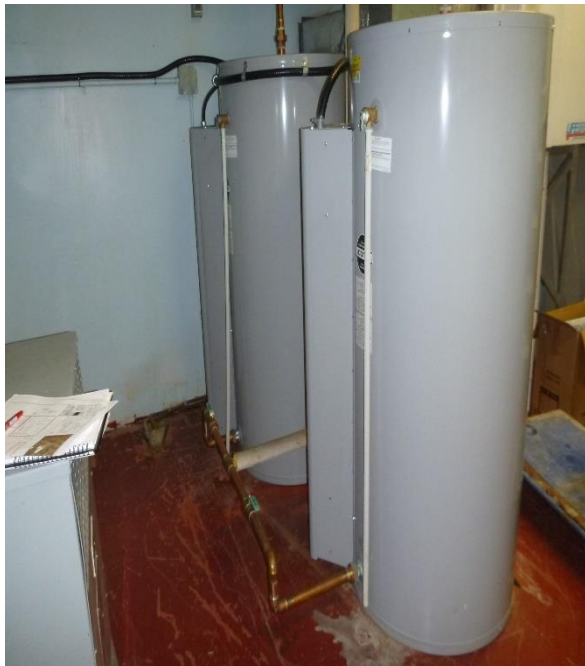
Figure 15 – Arena dressing room water heaters

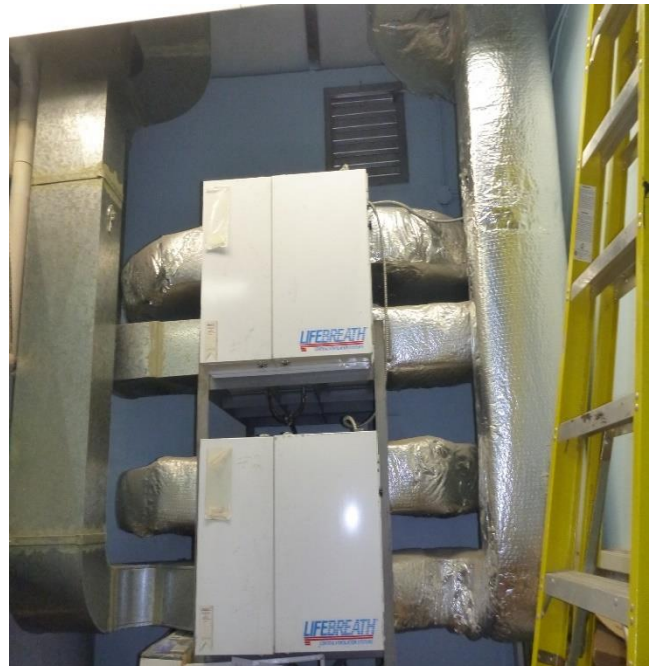
Figure 16– Arena dressing room ventilation units

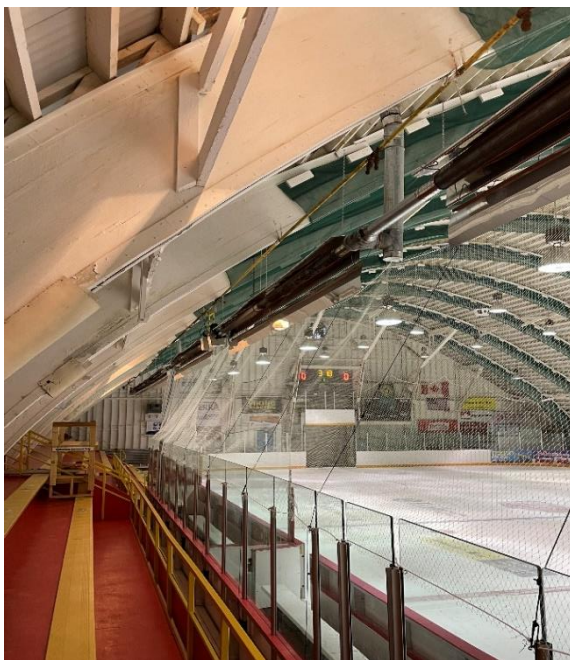
Figure 19– Seating/bleacher's radiant tube heaters

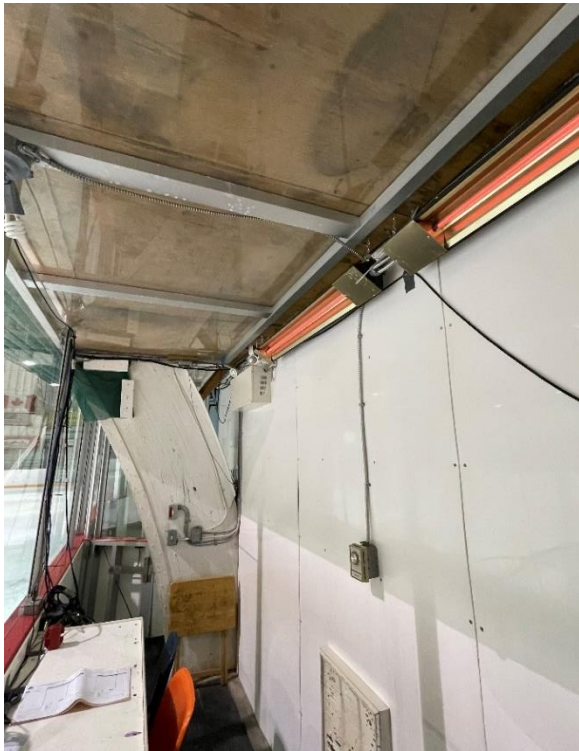
Figure 21– Scorer's electric infrared radiant heaters

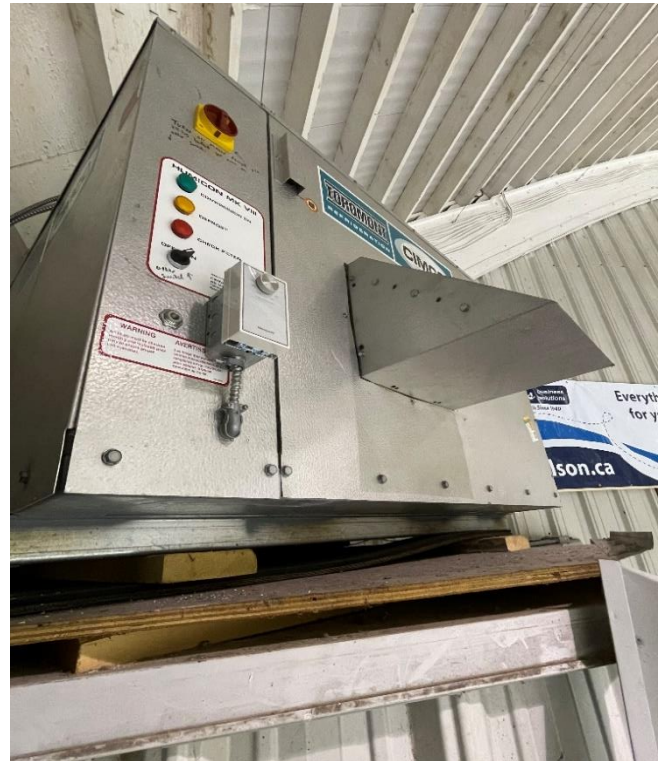
Figure 22– Ice Rink's dehumidifier

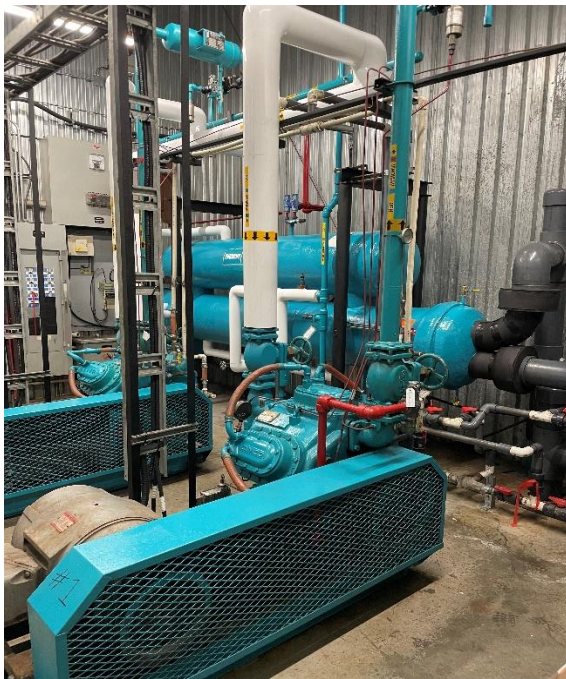
Figure 23– Ammonia refrigeration compressors and evaporator

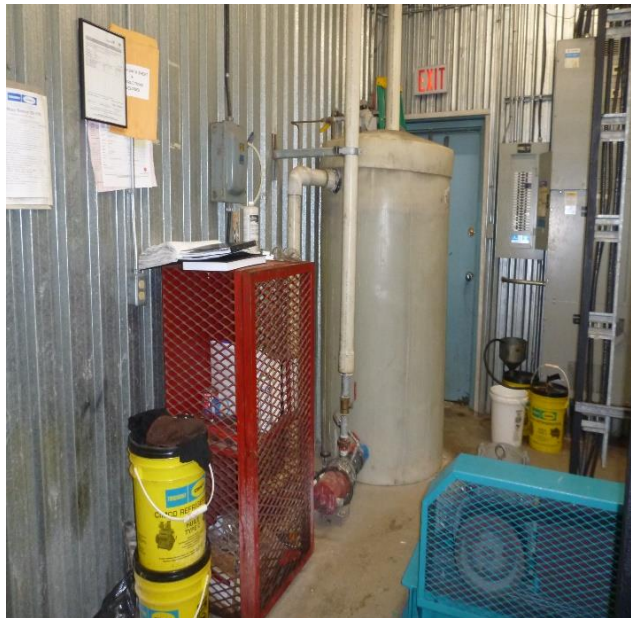
Figure 25– Glycol System

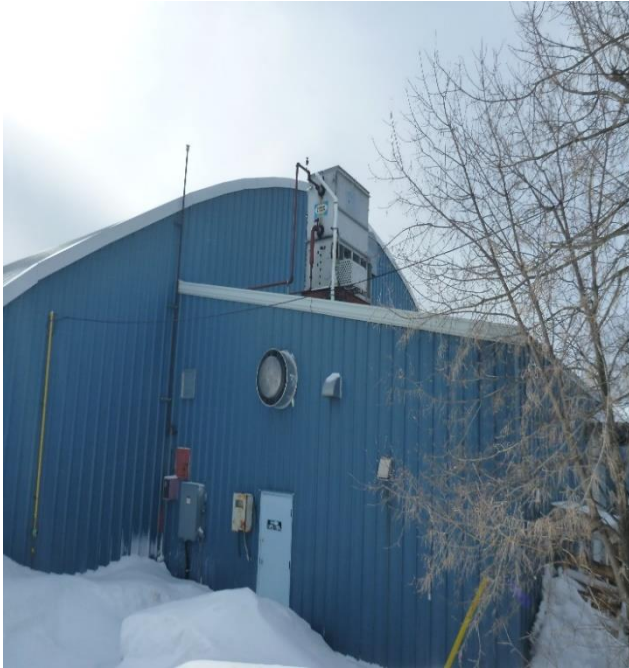
Figure 28– Leak detection strobe light and emergency eyewash/shower

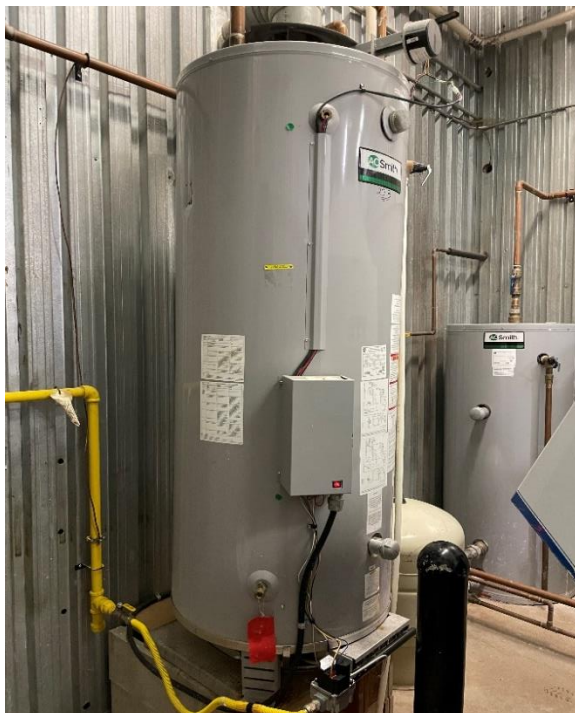
Figure 30– Ice rink electric water heaters

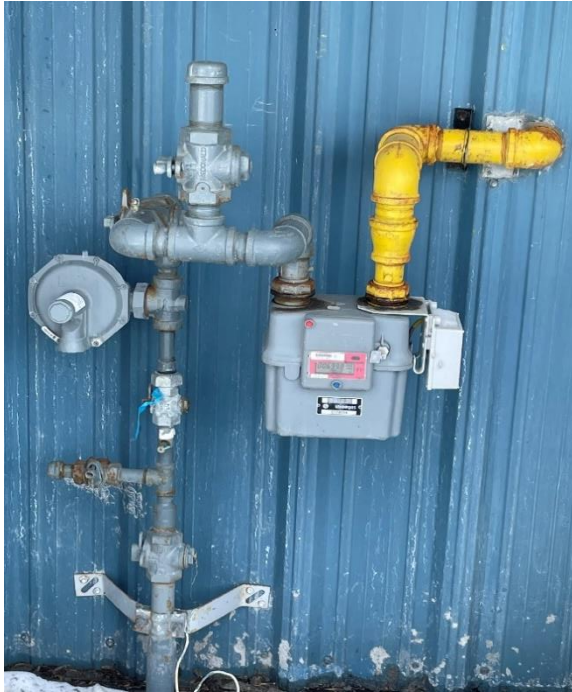
Figure 33– Natural gas service to ice rink water heater

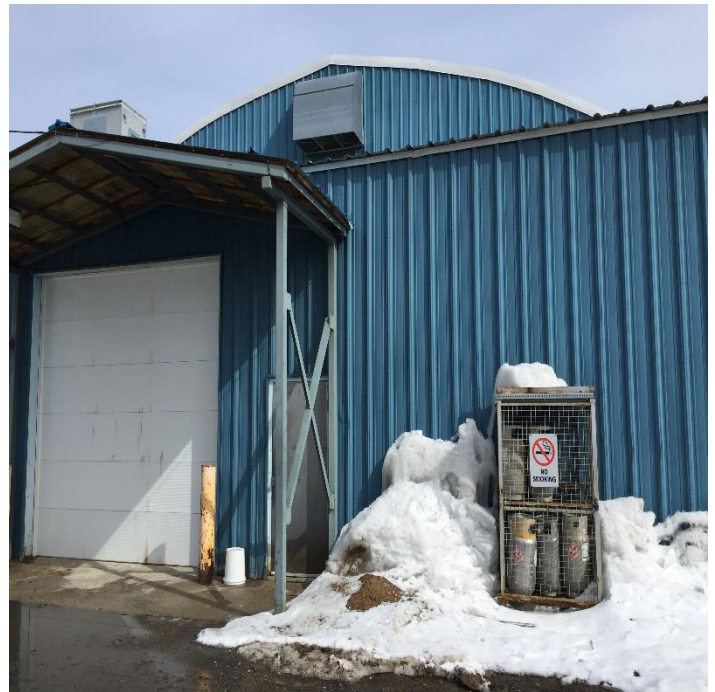
Figure 34– Propane gas tank and ice rink's southeast ventilation fan

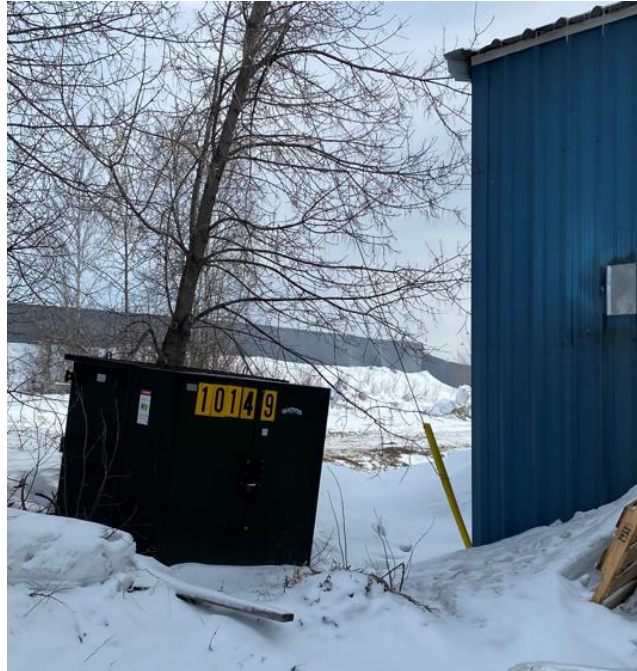
Figure 1 – Utility transformer

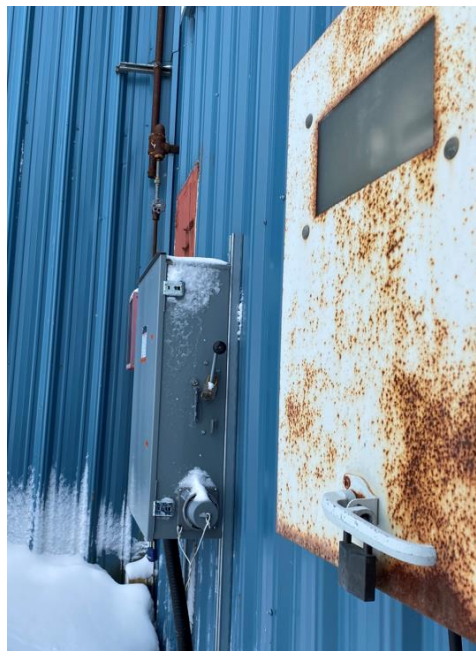
Figure 2 – Meter and portable generator plug-in

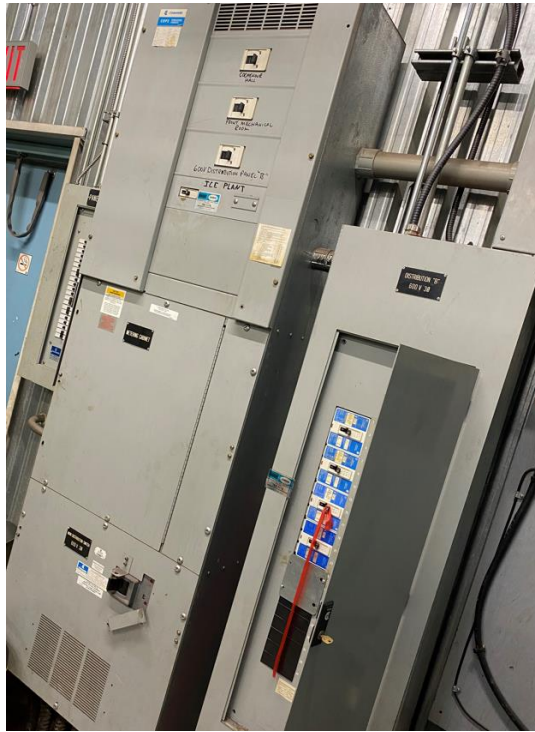
Figure 3 – Electrical layout in the [back] mechanical room

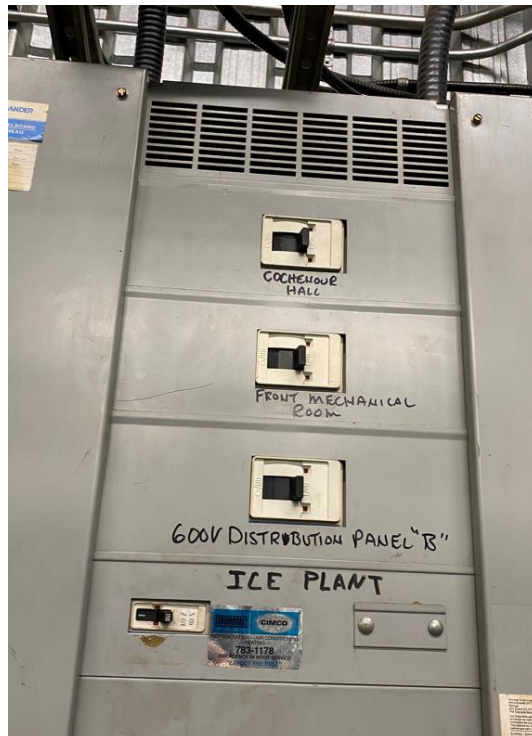
Figure 4 – Main Distribution Panel

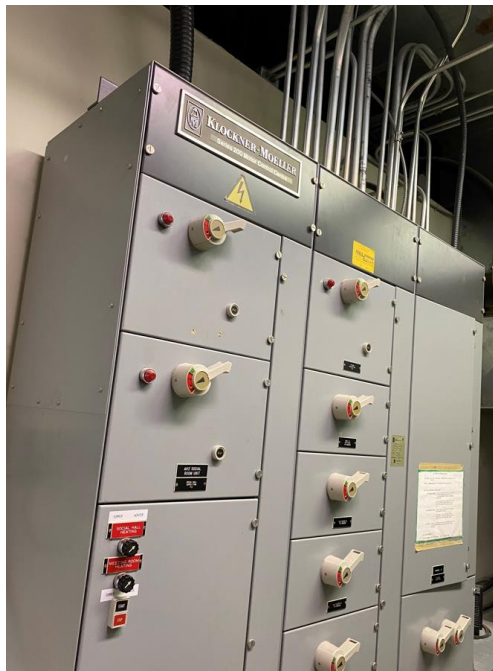
Figure 6 – MCC located in Cochenour Community Hall

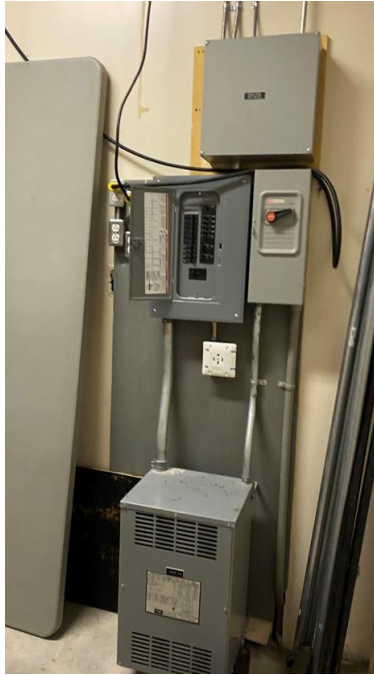
Figure 7 – Electrical panel by the stage

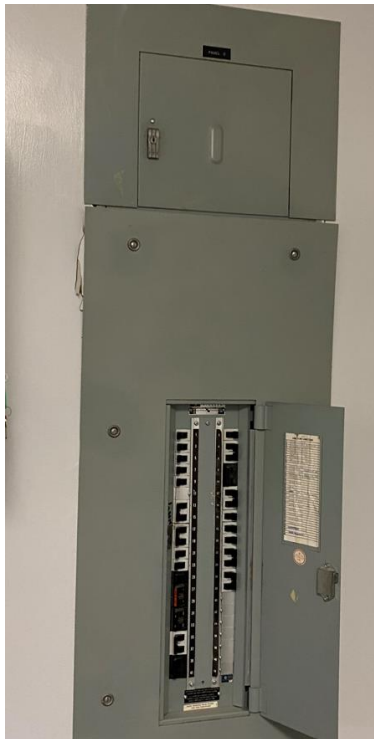
Figure 8 – Kitchen panel

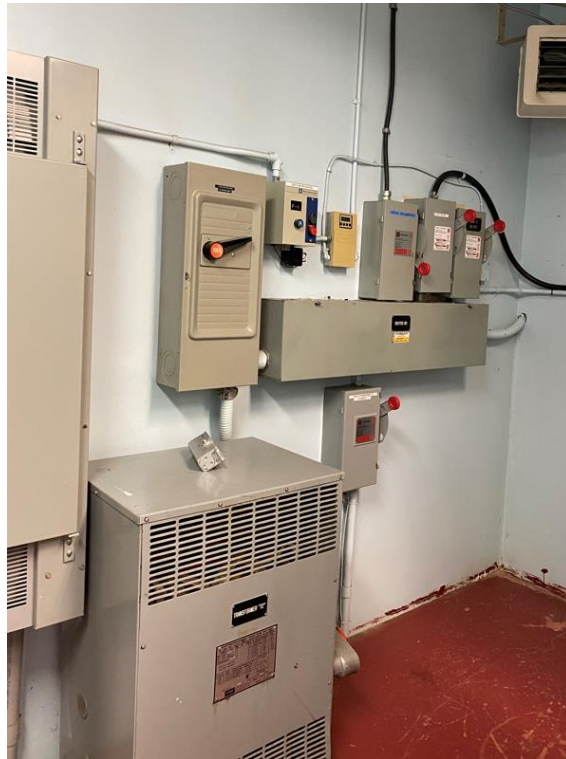
Figure 9 – Electrical layout in the [front] mechanical room

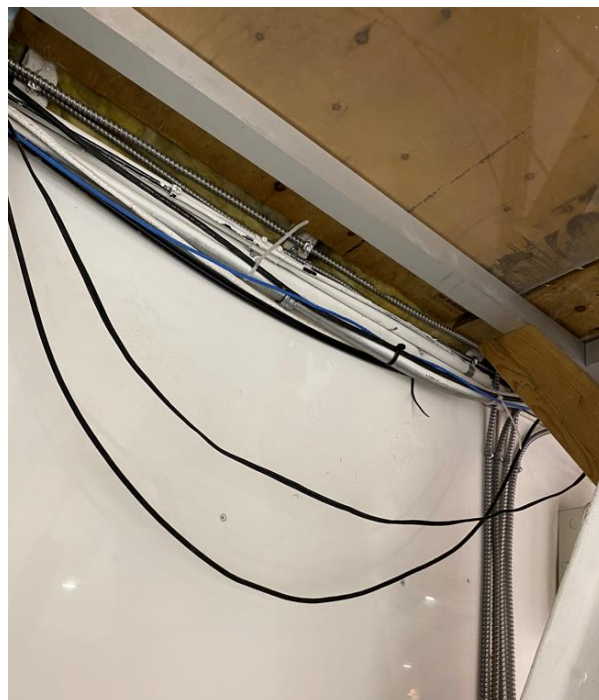
Figure 10 – Field wiring

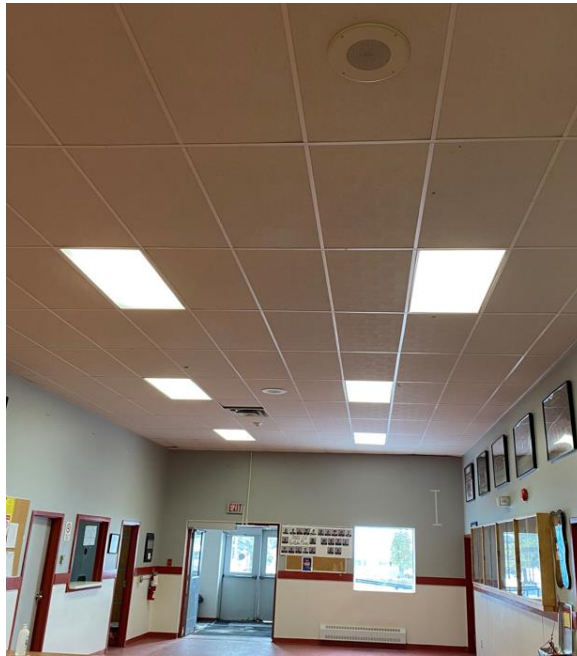
Figure 11 – General lighting

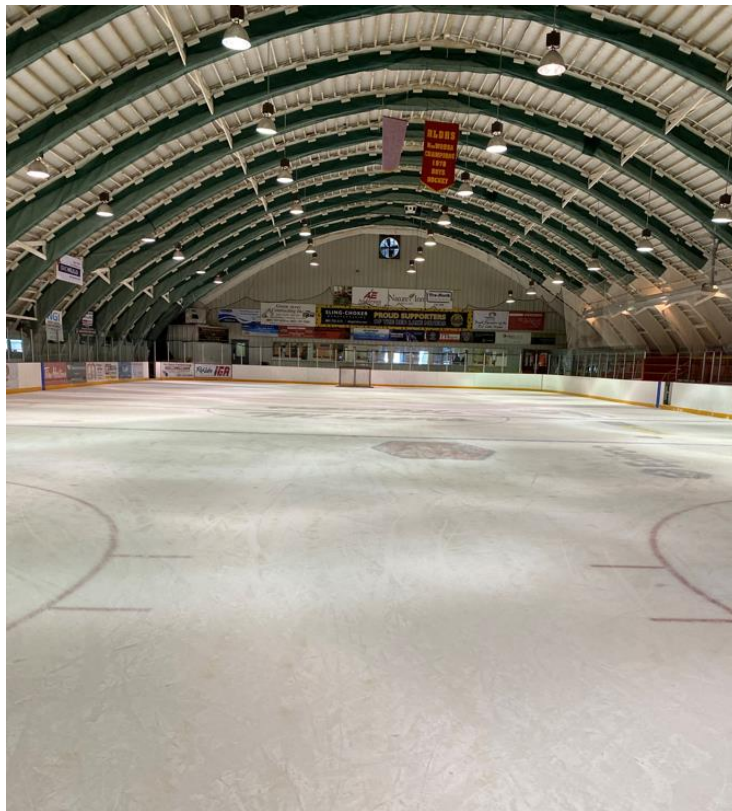
Figure 12 – Arena lighting

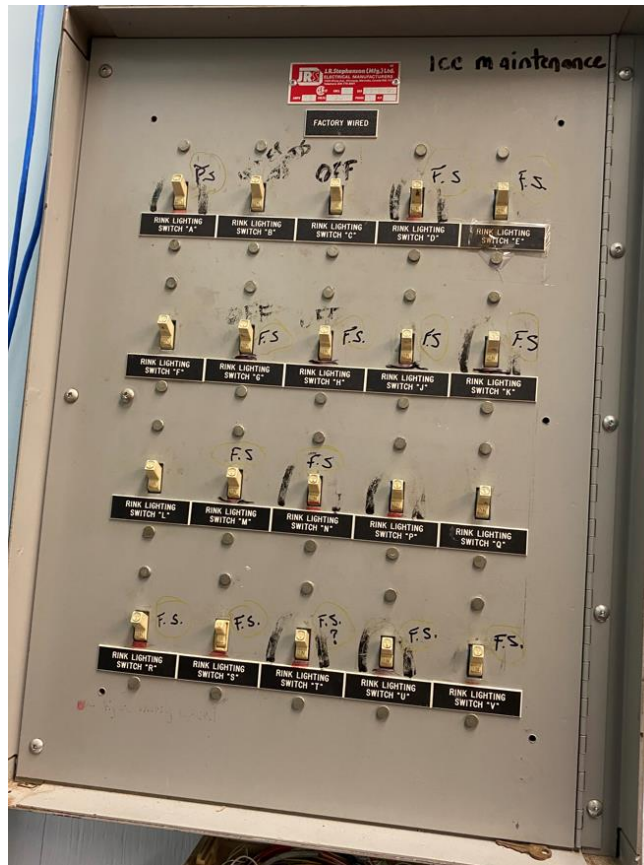
Figure 13 – Arena lighting Controls
