**Building Condition Assessment
(BCA)**

BCA Report for Cochenour Arena

10 William St.

Report Date
July 14, 2022

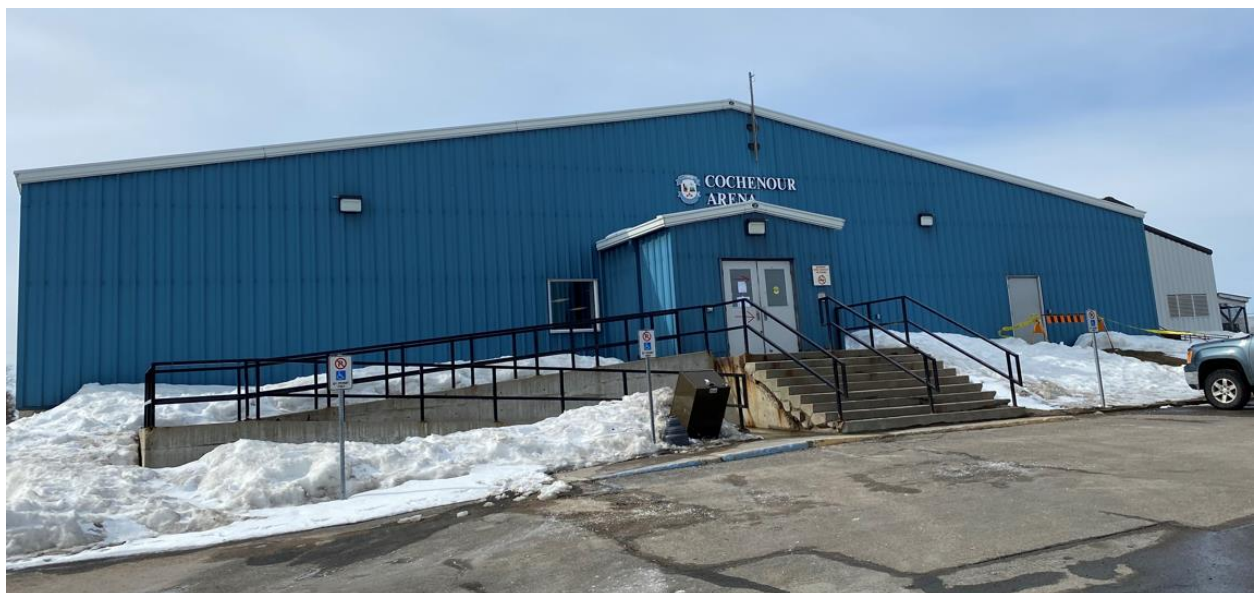
Figure 14 – Exterior lighting

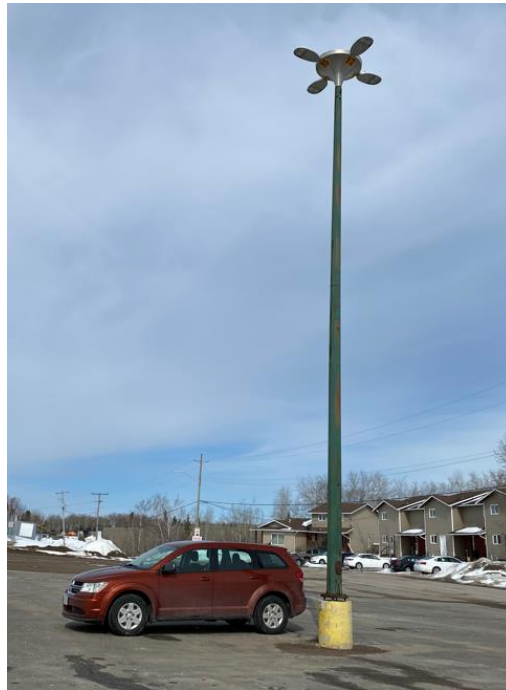
Figure 15 – Exterior lighting

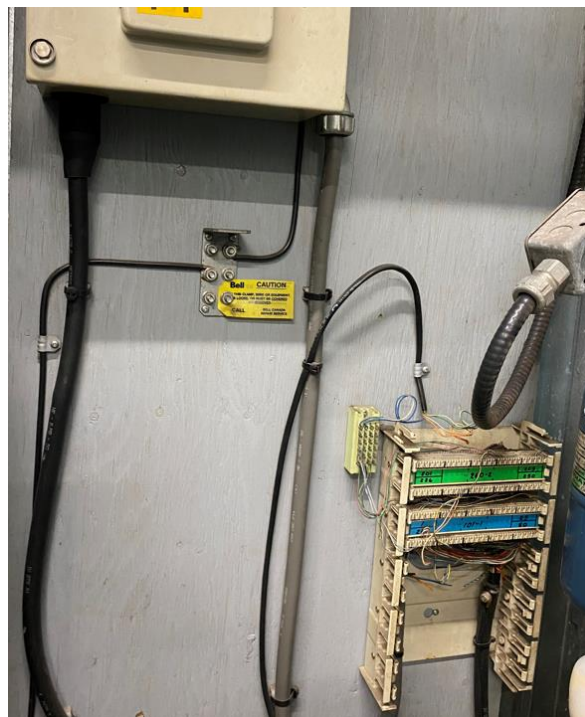
Figure 16 – Tbaytel termination in the [back] mechanical room

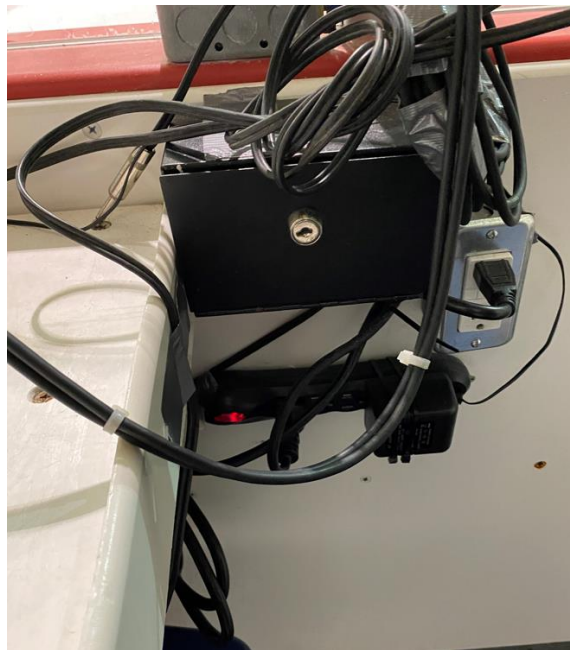
Figure 18 – P.A. system plug-in

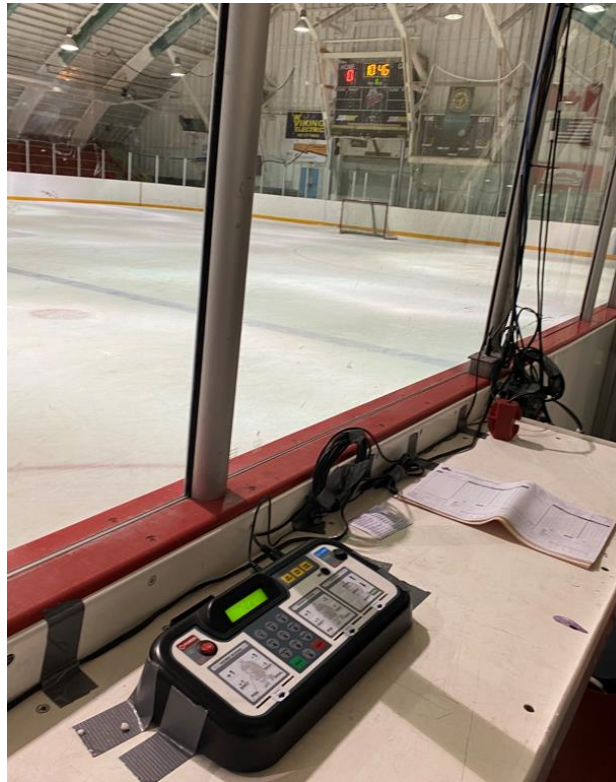
Figure 19 – Scoreboard system

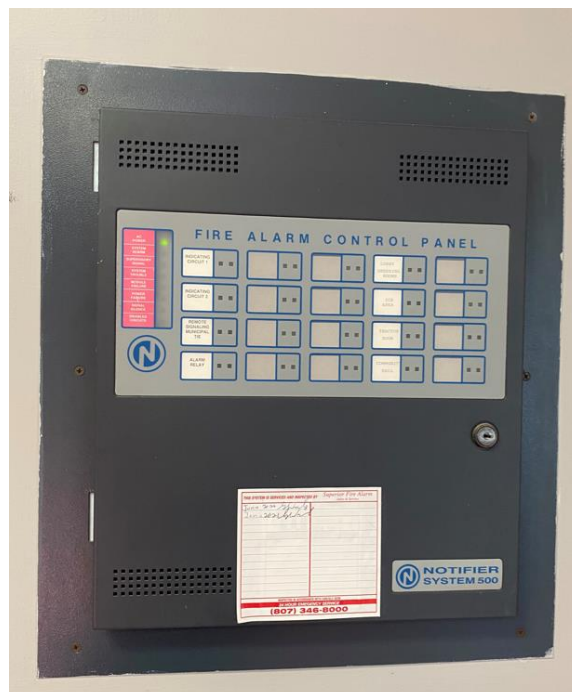
Figure 20 – Fire alarm control panel

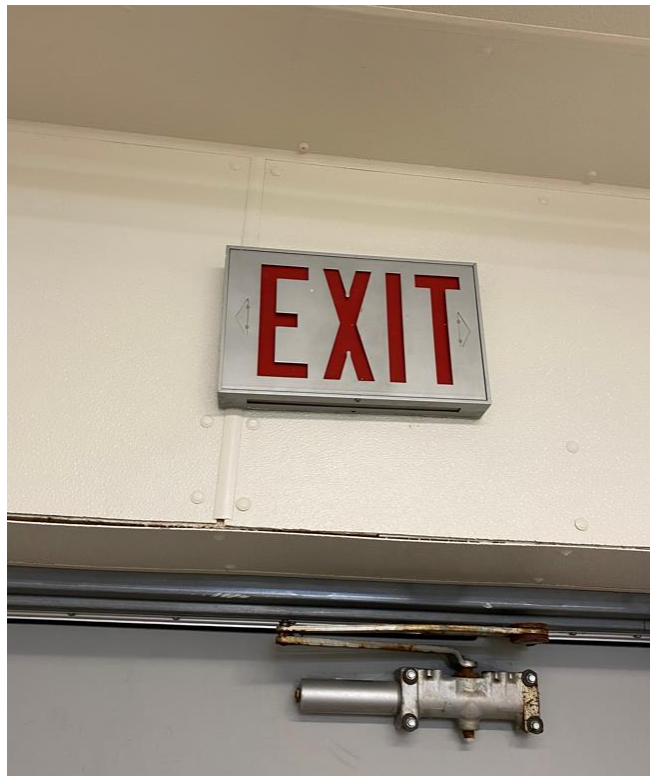
Figure 21 – Exit sign (no longer functional)

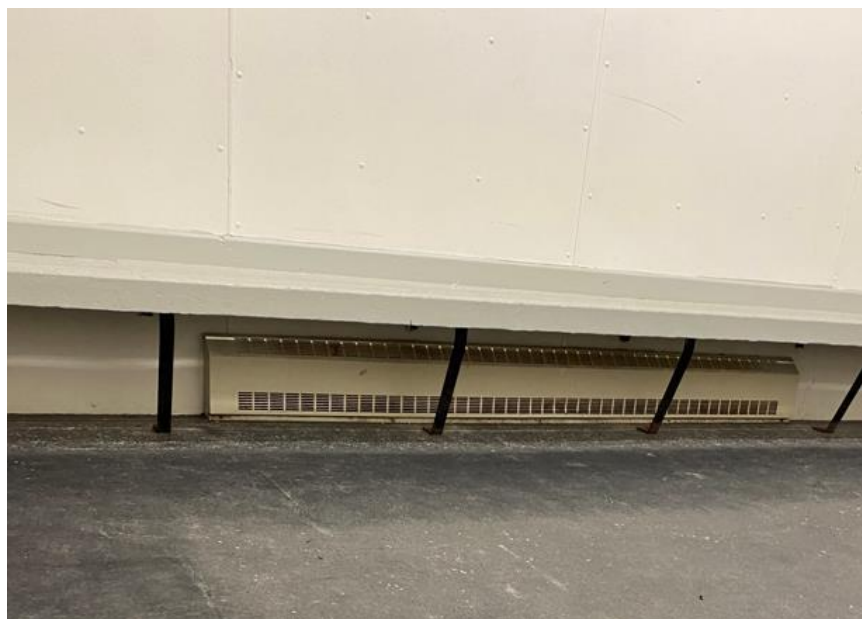
Figure 22 – Baseboard heater
